WETLAND DETERMINATION DATA FORM - North Central and Northeast Region

Project/Site: SPP	City/County: Aitkin		Sampling Date: 2016-08-09	
Applicant/Owner: Enbridge		State: Minnesota	Sampling Point: u-50n26w6-a5	
Investigator(s): ZCW, MGH	Section, Townsh	ip, Range: S6, T50N, R26W		
Landform (hillslope, terrace, etc.): Rise		Local Relief (concave, cor		
Subregion (LRR or MLRA):	Latitude: 4	•	itude: -93.68195096 Datum: NAD83	
Soil Map Unit Name: 292			NWI Classification: N/A	
Are climatic/hydrologic conditions on the site	typical for this time of year		·

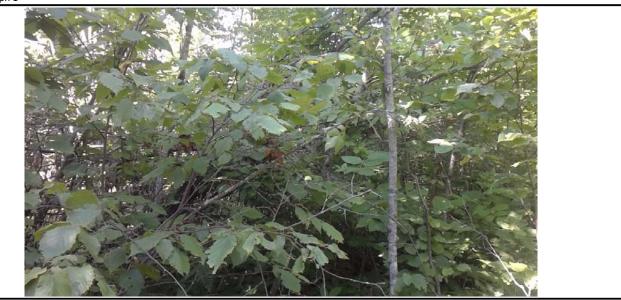
Site Photograph 1 Sampling Point: u-50n26w6-a5

Latitude:	46.8510758830671	Cowardin Classification:
Longitude:	-93.6819536426046	Circular 39:
Direction: Nor	rth	Eggers & Reed:
Remarks:		
Upland

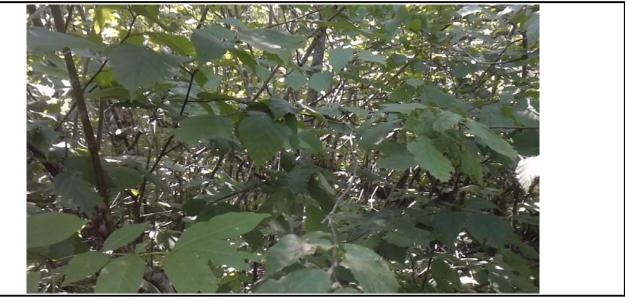
Site Photograph 2 Sampling Point: u-50n26w6-a5

3200	
Latitude:	46.851051827005	Cowardin Classification:
Longitude:	-93.6819846556463	Circular 39:
Direction: Wes	st	Eggers & Reed:
Remarks:		
Upland		
1
