WETLAND DETERMINATION DATA FORM - North Central and Northeast Region

Site Photograph 1 Sampling Point: u-50n26w6-a6

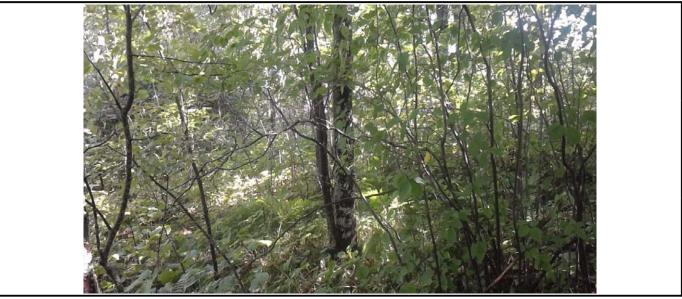
Latitude: 46.8485911516909	Cowardin Classification:
Longitude: -93.6776500382402	Circular 39:
ection: North	Eggers & Reed:
marks:	
pland

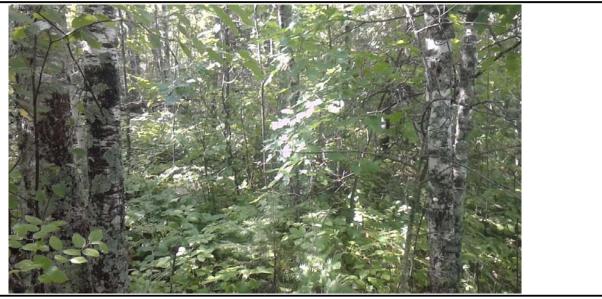
Site Photograph 2 Sampling Point: u-50n26w6-a6

atitude: 46.8485905649577	Cowardin Classification:		
Longitude: -93.6776488647737	Circular 39: Eggers & Reed:		
ction: South			
arks:			
nd
