WETLAND DETERMINATION DATA FORM - North Central and Northeast Region

Project/Site: SPP	City/County: Aitk	City/County: Aitkin		Sampling Date: 2016-08-10			
Applicant/Owner: Enbridge		State: Minnesota		Sampling Point: u-50n26w6-b1			
Investigator(s): ZCW, MGH	Section, To	ownship, Range: S6, T50N,	, R26W				
Landform (hillslope, terrace, etc.): Rise	e	Local Relief (conca	ve, convex, none): VL	Slope (%): 3-7%			
Subregion (LRR or MLRA):	Latitu	ıde: 46.8537812261	Longitude: -93.68338518	Datum: NAD83			
Soil Map Unit Name: 504B			NWI Cla	assification: N/A			
re climatic/hydrologic conditions on the site typical for this time of year? (if no, explain in Remarks): No							
Are Vegetation No , Soil No , or		, , , , ,	,				
Are Vegetation No_, Soil No_, or Hy	ydrology No naturally prob	lematic? (If needed, expl	ain any answers in Remarks)				
SUMMARY OF FINDINGS - Attach site map showing sampling point locations, transects, important features, etc.							
Hydrophytic Vegetation Present?	<u>No</u>	Is the Sampled Are	ea

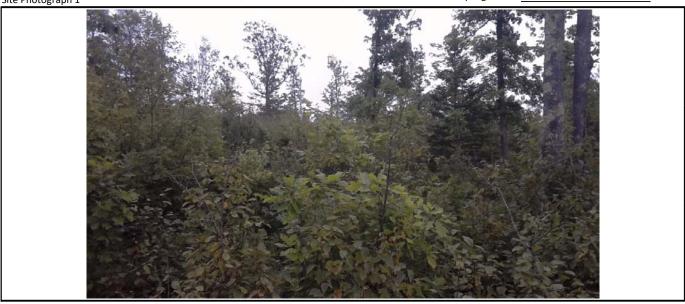
Site Photograph 1 Sampling Point: u-50n26w6-b1

Cowardin Classification:			
Circular 39:			
Eggers & Reed:

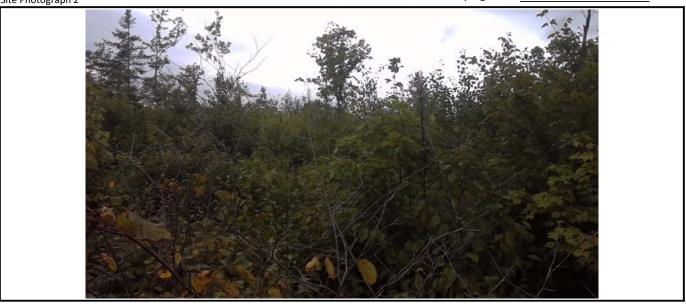
Site Photograph 2 Sampling Point: u-50n26w6-b1

A Committee of the control of the co				
Latitude: 46.8537788792018	Cowardin Classification:			
Longitude: -93.6833833438285	Circular 39:			
irection: West				
lemarks:				
Jpland
