WETLAND DETERMINATION DATA FORM - North Central and Northeast Region

Project/Site: SPP	City/County: Aitkin		Sampling Date: 2016-08-10			
Applicant/Owner: Enbridge		State: Minnesota	Sampling Point: u-50n26w6-c1			
Investigator(s): ZCW, MGH	Section, Town	ship, Range: <u>S6, T50N, R26\</u>	W			
Landform (hillslope, terrace, etc.): Side Slop	pe	Local Relief (concave, co	onvex, none): <u>VL</u> Slope (%): <u>3-7%</u>			
Subregion (LRR or MLRA):	Latitude:	46.8529936206 Lon	ngitude: -93.68189865 Datum: NAD83			
Soil Map Unit Name: 504B			NWI Classification: N/A			
Are climatic/hydrologic conditions on the s	site typical for this time of ye	ear? (if no, explain in Remar	rks): No			
Are Vegetation No_, Soil No_, or Hydro	rology No_ significantly dist	urbed? Are "Normal Circun	mstances" present? Yes			
Are Vegetation No_, Soil No_, or Hydrology No_ naturally problematic? (If needed, explain any answers in Remarks)						
SUMMARY OF FINDINGS - Attach site n	map showing sampling poin	t locations, transects, impo	ortant features, etc.

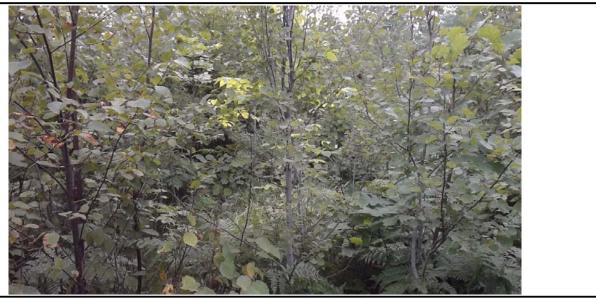
Site Photograph 1 Sampling Point: u-50n26w6-c1

Latitude: 46.8530014995922	Cowardin Classification:		
Longitude: -93.6819295865425	Circular 39:		
Direction: East	Eggers & Reed:		
Remarks:			
Upland

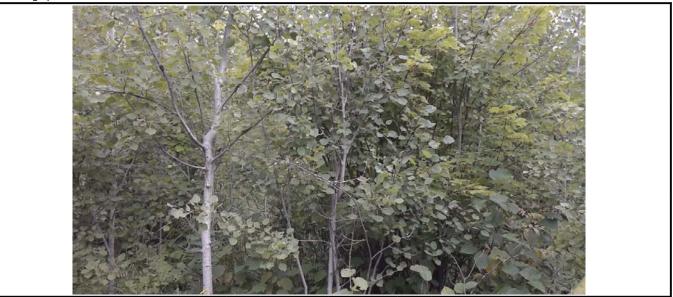
Site Photograph 2 Sampling Point: u-50n26w6-c1

其為學學。	
Latitude: 46.8530013319541	Cowardin Classification:
Longitude: -93.6819298379996	Circular 39:
Direction: North	Eggers & Reed:
Remarks:	
Upland
