## WETLAND DETERMINATION DATA FORM - North Central and Northeast Region

Project/Site: SPP	City/County: Ait	kin	Samplin	ng Date: 2016-08-11	
Applicant/Owner: Enbridge		State: Minnesota	Samplir	ng Point: u-50n26w6-e1	
Investigator(s): ZCW, MGH	Section, T	ownship, Range: S6, T50W,	R26W		
Landform (hillslope, terrace, etc.): Sid	e Slope	Local Relief (concav	ve, convex, none): VV	Slope (%): 3-7%	
Subregion (LRR or MLRA):	Latit	ude: 46.8557138834	Longitude: -93.67948969	Datum: NAD83	
Soil Map Unit Name: 504B			NWI Cla	ssification: N/A	
·	the site typical for this time	of year? (if no, explain in Re		No	
Are Vegetation No_, Soil No_, or	Hydrology NO significantly	disturbed? Are "Normal Ci	rcumstances" present? Yes		
Are Vegetation No_, Soil No_, or Hydrology No_ naturally problematic? (If needed, explain any answers in Remarks)					
SUMMARY OF FINDINGS - Attach :	site map showing sampling	point locations, transects, in	mportant features, etc.		
Hydrophytic Vegetation Present?	<u>No</u>	Is the Sampled Are	a

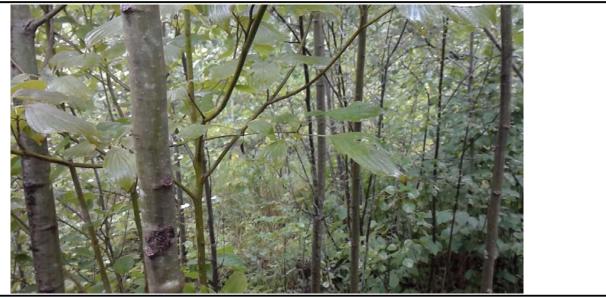
Site Photograph 2 Sampling Point: u-50n26w6-e1

Latitude:	46.8556683278148	Cowardin Classification:
Longitude:	-93.679438820196	Circular 39:
Direction: Wes	st	Eggers & Reed:
Remarks:		
Upland
