## WETLAND DETERMINATION DATA FORM - North Central and Northeast Region

Project/Site: SPP	City/County: Aitkin		Sampling Date: 2016-08-12		
Applicant/Owner: Enbridge		State: Minnesota	Sampling Point: u-50n26w6-i1		
Investigator(s): ZCW, MGH					
Landform (hillslope, terrace, etc.): Rise					
Subregion (LRR or MLRA):	Latitude: 4	,	gitude: -93.68228690 Datum: NAD83		
Soil Map Unit Name: 292			NWI Classification: N/A		
Are climatic/hydrologic conditions on the site typical for this time of year? (if no, explain in Remarks):  No					
Are Vegetation No , Soil No , or Hydrolog	y No significantly distur	bed? Are "Normal Circum	stances" present? <u>Yes</u>		
Are Vegetation No_, Soil No_, or Hydrology	No naturally problemati	ic? (If needed, explain any	answers in Remarks)		
SUMMARY OF FINDINGS - Attach site map	showing sampling point le	ocations transacts impor	tant features etc		
Hydrophytic Vegetation Present?	No	Is the Sampled Area	tant reatures, etc.		
Hydric Soil Present?	No	within a Wetland?	No

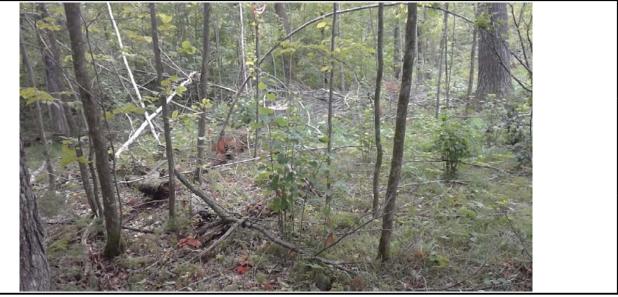
Site Photograph 1 Sampling Point: u-50n26w6-i1

Latitude: 46.8455967586924	Cowardin Classification:		
Longitude: -93.6822765135147	Circular 39:		
Direction: South	Eggers & Reed:		
Remarks:
