WETLAND DETERMINATION DATA FORM - North Central and Northeast Region

Project/Site: SPP	City/County: Aitkin		Sampling Date: 2016-08-12			
Applicant/Owner: Enbridge		State: Minnesota	Sampling Point: u-50n26w6-k1			
Investigator(s): ZCW, MGH	Section, Townshi	ip, Range:				
Landform (hillslope, terrace, etc.): Side Slope		Local Relief (concave, con	vex, none): VV Slope (%): 8-15%			
Subregion (LRR or MLRA):	Latitude: 4		itude: -93.68164904 Datum: NAD83			
Soil Map Unit Name: 504B			NWI Classification: N/A

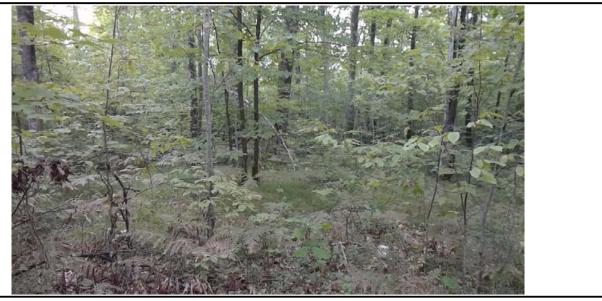
Site Photograph 2 Sampling Point: u-50n26w6-k1

Latitude: 46.8428973248665	Cowardin Classification:	
Longitude: -93.6815802288183	Circular 39:	
Direction: East	Eggers & Reed:	
Remarks:
