WETLAND DETERMINATION DATA FORM - North Central and Northeast Region

Project/Site: SPP	City/County: Aitk	City/County: Aitkin		Sampling Date: 2016-08-16	
Applicant/Owner: Enbridge		State: Minnesota	Samplin	g Point: <u>u-50n26w7-b1</u>	
Investigator(s): ZCW, MGH	Section, To	ownship, Range: S7, T50N, F	R26W		
Landform (hillslope, terrace, etc.): Ris	e	Local Relief (concave	e, convex, none): VL	Slope (%): <u>0-2%</u>	
Subregion (LRR or MLRA):	Latitı	ıde: 46.8285195948	Longitude: -93.68120698	Datum: NAD83	
Soil Map Unit Name: 204B			NWI Clas	ssification: N/A	
Are climatic/hydrologic conditions or	the site typical for this time	of year? (if no, explain in Re	marks):	No	
Ana Manakatian No Gail No		distante da Ara IIN accesal Ci	, Voc		
Are Vegetation No , Soil No , or	Hydrology NO significantly	disturbed? Are "Normal Cil	rcumstances" present? 1es_		
Are Vegetation No_, Soil No_, or H	ydrology <u>No</u> naturally prob	lematic? (If needed, explai	n any answers in Remarks)

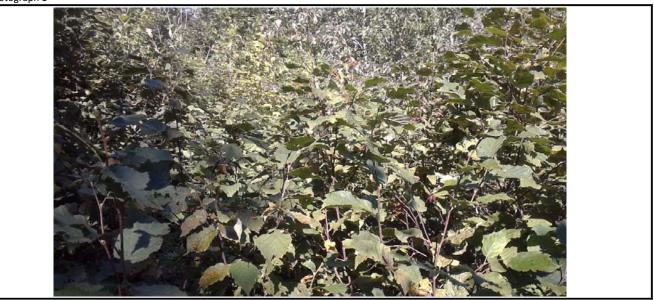
Site Photograph 1 Sampling Point: u-50n26w7-b1

Latitude:	46.8285193015326	Cowardin Classification:	
Longitude:	-93.6812066473939	Circular 39:	
Direction: Wes	t	Eggers & Reed:	
Remarks:			
Upland

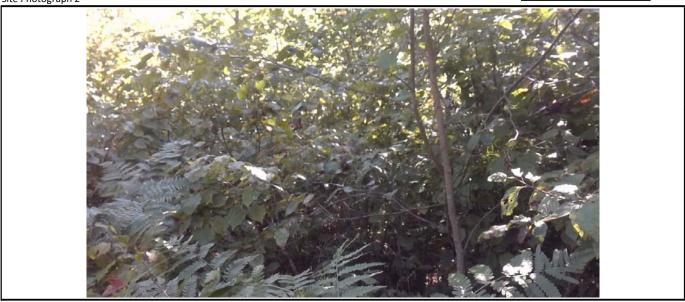
Site Photograph 2 Sampling Point: u-50n26w7-b1

Latitude: 46.8285193434421	Cowardin Classification:		
Longitude: -93.6812065635749	Circular 39:		
Direction: East	Eggers & Reed:		
Remarks:			
Up and
