WETLAND DETERMINATION DATA FORM - North Central and Northeast Region

Site Photograph 1 Sampling Point: u-50n26w7-g1

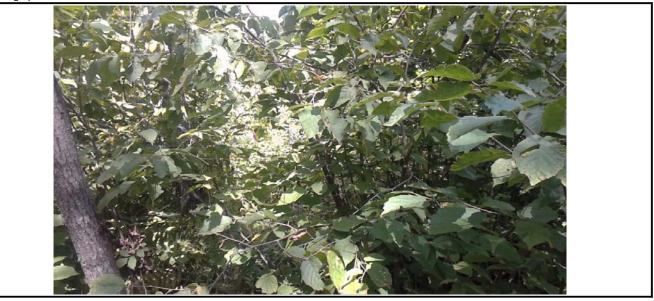
Site Photograph 2 Sampling Point: u-50n26w7-g1

Latitude: 46.8360867770825	Cowardin Classification:			
Longitude: -93.6831434537598	Circular 39:			
Direction: East	Eggers & Reed:			
Remarks:				
Upland
