## WETLAND DETERMINATION DATA FORM - North Central and Northeast Region

Project/Site: SPP	City/County: Aitkin		Sampling Date: 2016-08-16		
Applicant/Owner: Enbridge		State: Minnesota	Sampling Point: u-50n2	6w7-h1	
Investigator(s): ZCW, MGH	Section, Townsh	ip, Range: <u>S7, T50N, R26W</u>			
Landform (hillslope, terrace, etc.): Side Slo	pe	Local Relief (concave, conv	ex, none): VL Slope (9	%): 3-7%	
Subregion (LRR or MLRA):	 Latitude: 4	6.8378398521 Longit	 ude: -93.68293357 Datum: NAI	 D83	
Soil Map Unit Name: 292	<u> </u>		NWI Classification: N/A

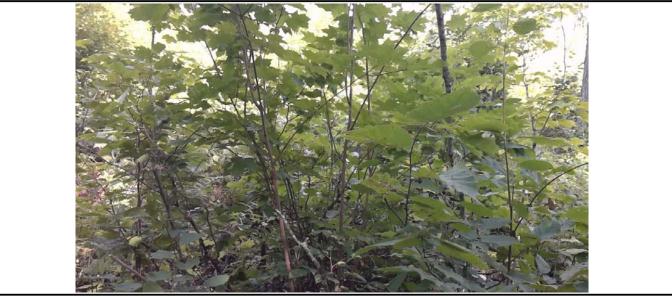
Site Photograph 1 Sampling Point: u-50n26w7-h1

titude: 46.8378517544333	Cowardin Classification:
ongitude: -93.6829762347915	Circular 39:
tion: North	Eggers & Reed:
arks:	
nd

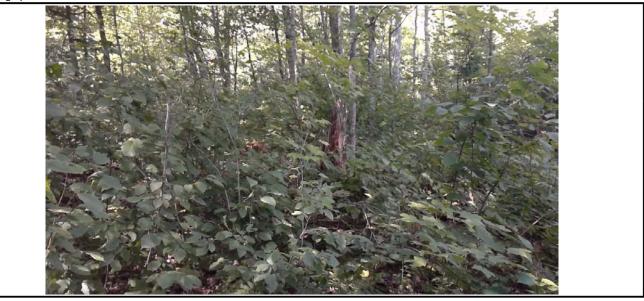
Site Photograph 2 Sampling Point: u-50n26w7-h1

Contract of the second	
Latitude:	46.8378622318123	Cowardin Classification:
Longitude:	: -93.6829657574125	Circular 39:
Direction: We	st	Eggers & Reed:
Remarks:		
Upland
