WETLAND DETERMINATION DATA FORM - North Central and Northeast Region

Project/Site: SPP	City/County:	City/County: Aitkin			Sampling Date: 2016-08-17		
Applicant/Owner: Enbridge		:	State: Minnesota	Sa	ampling Point: <u>u-50n2</u>	6w7-j1	
Investigator(s): ZCW, MGH	Section	n, Township	, Range: <u>S7, T50N, R2</u>	6W			
Landform (hillslope, terrace, etc.): Side Slo	ope		Local Relief (concave,	convex, none): VV	Slope (%): 3-7%	
Subregion (LRR or MLRA):	La	ititude: 46.	8356751418 Lo	ongitude: -93.681489	—— 995	 D83	
Soil Map Unit Name: 209B				N\	WI Classification: N/A		
Are climatic/hydrologic conditions on the	site typical for this tir	ne of vear?	(if no. explain in Rema	_	No		
Are Vegetation No_, Soil No_, or Hydrology No_ significantly disturbed? Are "Normal Circumstances" present? Yes_							
Are Vegetation No_, Soil No_, or Hydrology No_ naturally problematic? (If needed, explain any answers in Remarks)							
SUMMARY OF FINDINGS - Attach site	map showing samplin			ortant features, etc

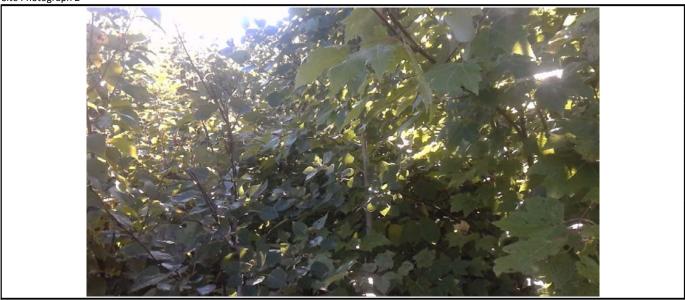
Site Photograph 2 Sampling Point: u-50n26w7-j1

Latitude: 46.8356628623296	Cowardin Classification:
Longitude: -93.6814898719021	Circular 39:
Direction: East	Eggers & Reed:
Remarks:	
Upland
