## WETLAND DETERMINATION DATA FORM - North Central and Northeast Region

Project/Site: SPP	City/County: Aitkin		Sampling Date: 2016-08-17	
Applicant/Owner: Enbridge		State: Minnesota	Sampling Point: u-50n26w7-k1	
Investigator(s): ZCW, MGH	Section, Townsh	ip, Range: S7, T50N, R26W		
Landform (hillslope, terrace, etc.): Side Slope	<u> </u>	Local Relief (concave, cor		
Subregion (LRR or MLRA):	 Latitude: 4	•	itude: -93.68141284 Datum: NAD83	
Soil Map Unit Name: 292			NWI Classification: N/A	
Are climatic/hydrologic conditions on the site t	vnical for this time of year	? (if no explain in Remark	·	
Are Vegetation No , Soil No , or Hydrolog	/ No significantly distur	bed? Are "Normal Circum	stances" present? <u>Yes</u>	
Are Vegetation No , Soil No , or Hydrology	No naturally problemati	c? (If needed, explain any	answers in Remarks)	
SUMMARY OF FINDINGS - Attach site map	showing sampling point le	ocations transacts impor	tant features, etc	
Hydrophytic Vegetation Present?	No	Is the Sampled Area	tant leatures, etc.

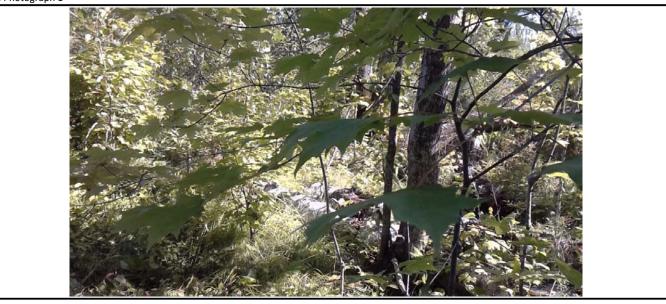
Site Photograph 1 Sampling Point: u-50n26w7-k1

Latitude:	46.840249188288	Cowardin Classification:			
Longitude	e: -93.6813761294761	Circular 39:			
Direction: No	orth	Eggers & Reed:			
Remarks:					
Upland

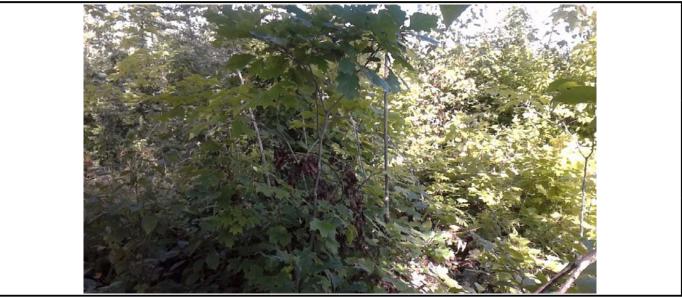
Site Photograph 2 Sampling Point: u-50n26w7-k1

Latitude:	46.8402533792395	Cowardin Classification:	
Longitude:	-93.6813727767148	Circular 39:	
Direction: Wes	st	Eggers & Reed:	
Remarks:			
Upland
