WETLAND DETERMINATION DATA FORM - North Central and Northeast Region

Project/Site: SPP	City/County: Ait	City/County: Aitkin		Sampling Date: 2016-08-17	
Applicant/Owner: Enbridge		State: Minnesota	Samplin	g Point: u-50n26w7-l1	
Investigator(s): ZCW, MGH	Section, T	ownship, Range: S7, T50N, R	26W		
Landform (hillslope, terrace, etc.): Rise		Local Relief (concave,	, convex, none): VV	Slope (%): 3-7%	
Subregion (LRR or MLRA):	Latit	ude: 46.8406518549 L	Longitude: -93.68052461	Datum: NAD83	
Soil Map Unit Name: 292			NWI Cla	ssification: N/A	
Are climatic/hydrologic conditions on th	ne site typical for this time	of year? (if no, explain in Ren		No	
	••	, , , ,	•		
Are Vegetation No , Soil No , or Hy	drology NO significantly	disturbed? Are "Normal Circ	cumstances" present? Yes		
Are Vegetation No , Soil No , or Hyd	rology No naturally prof	olematic? (If needed, explain	any answers in Remarks)		
SUMMARY OF FINDINGS - Attach sit	e map showing sampling	point locations, transects, im	portant features, etc.

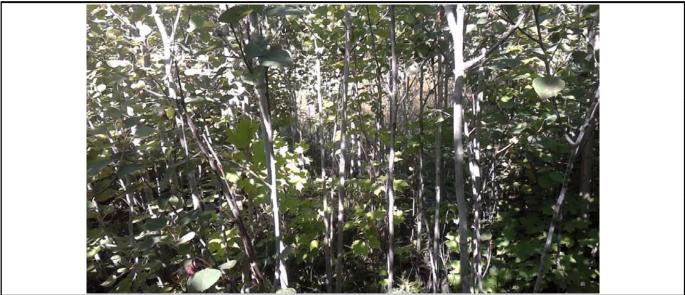
Site Photograph 1 Sampling Point: u-50n26w7-l1

Latitude: 46.840644353113	Cowardin Classification:
Longitude: -93.6805346702167	Circular 39:
Direction: West	Eggers & Reed:
Remarks:	
Upland

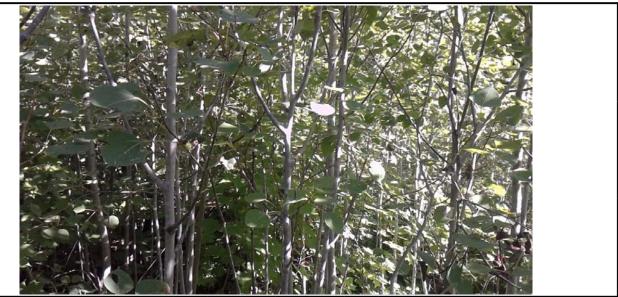
Site Photograph 2 Sampling Point: u-50n26w7-l1

Latitude:	46.8406231888075	Cowardin Classification:
Longitude:	-93.680522265	Circular 39:
Direction: Nort	th	- Eggers & Reed:
Remarks:		
Upland
