WETLAND DETERMINATION DATA FORM - North Central and Northeast Region

| Project/Site: SPP | City/County: Aith | City/County: Aitkin | | Sampling Date: 2016-08-17 | |
| Applicant/Owner: Enbridge | | State: Minnesota | Samplir | ng Point: <u>u-50n26w7-n1</u> | |

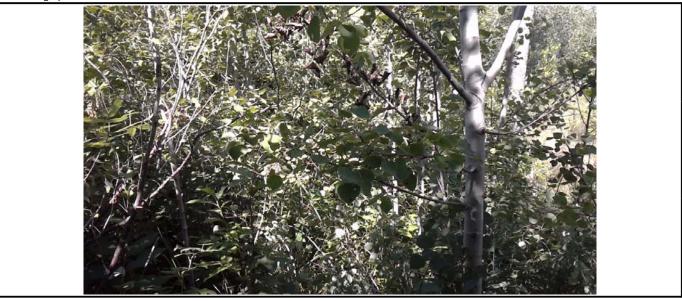
Site Photograph 1 Sampling Point: u-50n26w7-n1

| Latitude: 46.8395091500569 | Cowardin Classification: | | | | |
|---|---|--|--|--|--|
| Direction: West | Eggers & Reed: | | | | |
| Upland | | | | | |

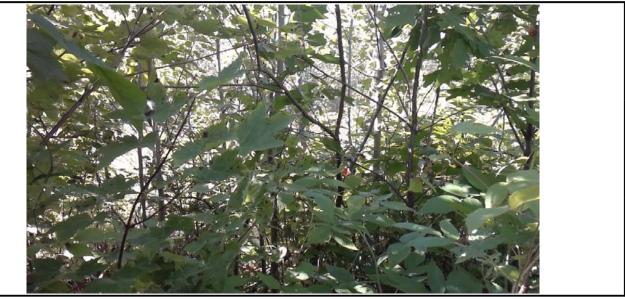
Site Photograph 2 Sampling Point: u-50n26w7-n1

| Latitude: | 46.8395089824189 | Cowardin Classification: | |
|---|---|---|--|
| Direction: Sou | th | Eggers & Reed: | |
| Upland | | | |
