WETLAND DETERMINATION DATA FORM - North Central and Northeast Region

Project/Site: SPP	City/County: Aitkin		Sampling Date: 2016-08-17			
Applicant/Owner: Enbridge		State: Minnesota	Sampling Point: u-50n26w7-o1			
Investigator(s): ZCW, MGH						
Landform (hillslope, terrace, etc.): Rise		Local Relief (concave, cor	nvex, none): VV Slope (%): 0-2%			
Subregion (LRR or MLRA):	Latitude: 40	•	itude: -93.68032780 Datum: NAD83			
Soil Map Unit Name: 292			NWI Classification: N/A			
·	typical for this time of year	r? (if no explain in Remark				
	Are climatic/hydrologic conditions on the site typical for this time of year? (if no, explain in Remarks):					
Are Vegetation No , Soil No , or Hydrole	ogy No significantly distur	bed? Are "Normal Circums	stances" present? Yes			
Are Vegetation No_, Soil No_, or Hydrolog	y <u>No</u> naturally problemati	c? (If needed, explain any	answers in Remarks)			
SUMMARY OF FINDINGS - Attach site ma	n showing sampling point l	ocations, transects, import	ant features, etc.

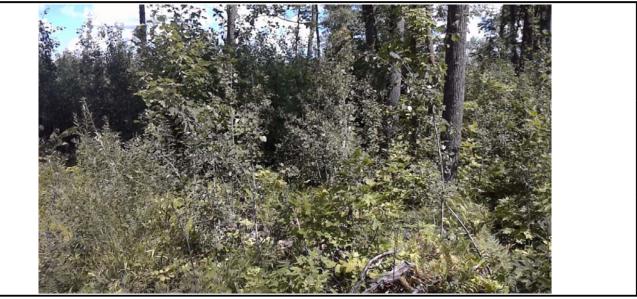
Site Photograph 1 Sampling Point: u-50n26w7-o1

Latitude: 46.8388868775655	Cowardin Classification:		
Longitude: -93.6799810455122	Circular 39:		
virection: North	Eggers & Reed:		
Remarks:			
Jpland

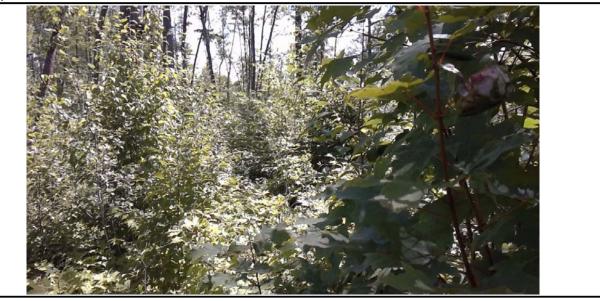
Site Photograph 2 Sampling Point: u-50n26w7-o1

Latitude:	46.838886919475	Cowardin Classification:		
Longitude:	-93.6799799558648	Circular 39:		
Direction: East		Eggers & Reed:		
Remarks:				
Upland
