WETLAND DETERMINATION DATA FORM - North Central and Northeast Region

Project/Site: SPP	City/County: Aitkin		Sampling Date: 2016-08-17			
Applicant/Owner: Enbridge		State: Minnesota	Sampling Point: u-50n26w7-s1			
Investigator(s): ZCW, MGH	Section, Townsh	ip, Range: <u>S7, T50N, R26W</u>				
Landform (hillslope, terrace, etc.): Rise		Local Relief (concave, conv	rex, none): VV Slope (%): 8-15%			
Subregion (LRR or MLRA):	Latitude: 4	6.8389693974 Longit	ude: -93.67824741 Datum: NAD83			
Soil Map Unit Name: 204B			NWI Classification: N/A			
Are climatic/hydrologic conditions on the si	ite typical for this time of year	r? (if no. explain in Remarks)				
Are Vegetation No , Soil No , or Hydro	ology No significantly distur	bed? Are "Normal Circumst	ances" present? Yes			
Are Vegetation No , Soil No , or Hydrology No naturally problematic? (If needed, explain any answers in Remarks) SUMMARY OF FINDINGS - Attach site map showing sampling point locations, transects, important features, etc.

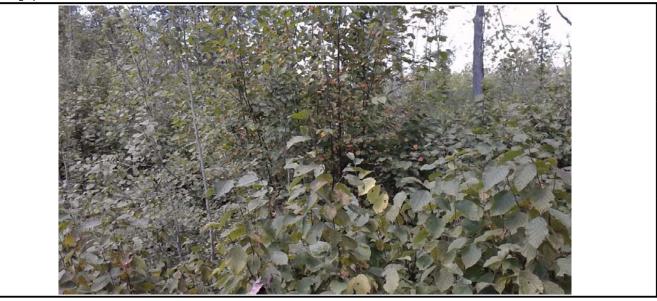
Site Photograph 1 Sampling Point: u-50n26w7-s1

Latitude: 46.8389669247408	Cowardin Classification:				
Longitude: -93.6782569718488	Circular 39:				
Direction: North	Eggers & Reed:				
Remarks:					
Upland
