WETLAND DETERMINATION DATA FORM - North Central and Northeast Region

Project/Site: SPP	City/County: <u>F</u>	City/County: Aitkin		Sampling Date: 2016-08-17	
Applicant/Owner: Enbridge		State: Minnesota	Samplii	ng Point: u-50n26w7-t1	
Investigator(s): ZCW, MGH	Section	, Township, Range: S7, T50N,	, R26W		
Landform (hillslope, terrace, etc.): Si	de Slope	Local Relief (conca	ve, convex, none): VV	Slope (%): 3-7%	
Subregion (LRR or MLRA):	La ⁺	titude: 46.839547664902	Longitude: -93.67840717	Datum: NAD83	
Soil Map Unit Name: 292			NWI Cla	ssification: N/A	
Are climatic/hydrologic conditions o	n the site typical for this tim	ne of year? (if no. explain in R		No	
, ,	••	, , , , ,	,		
Are Vegetation No , Soil No , o	r Hydrology <u>NO</u> significan	tly disturbed? Are "Normal (Circumstances" present? Yes		
Are Vegetation No , Soil No , or H	lydrology No naturally pr	oblematic? (If needed, expl	ain any answers in Remarks)		
SUMMARY OF FINDINGS - Attach		g point locations, transects,	important features, etc.

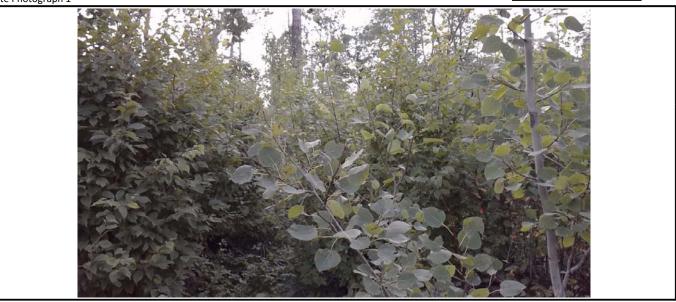
Site Photograph 1 Sampling Point: u-50n26w7-t1

Latitude: 46.839547664902	Cowardin Classification:		
Longitude: -93.6784073431917	Circular 39:		
ection: South	Eggers & Reed:		
marks:			
pland

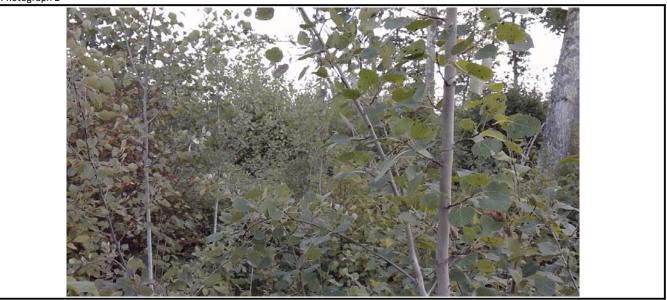
Site Photograph 2 Sampling Point: u-50n26w7-t1

Latitude: 46.839547664902	Cowardin Classification:	
Longitude: -93.6784071755537	Circular 39:	
Direction: East	Eggers & Reed:	
Remarks:		
Upland
