## WETLAND DETERMINATION DATA FORM - North Central and Northeast Region

| Project/Site: SPP | City/County: Aitkin | | Sampling Date: 2016-08-10 | |
| Applicant/Owner: Enbridge | | State: Minnesota | Sampling Point: u-51n26w31-ac1 | |

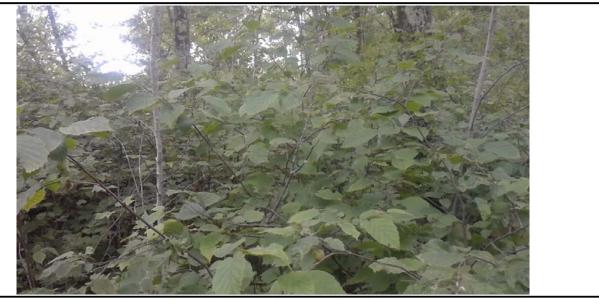
Site Photograph 1 Sampling Point: u-51n26w31-ac1

| | Shall be to the same of the sa | |
|---|--|---|
| Direction: Wes | st | Eggers & Reed: |
| Upland | | |

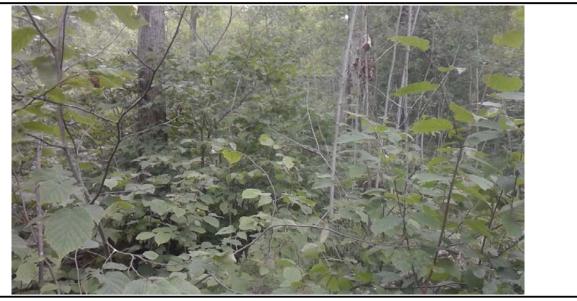
Site Photograph 2 Sampling Point: <u>u-51n26w31-ac1</u>

| Latitude: 46.8560556555603 | Cowardin Classification: | | |
|---|---|--|--|
| Direction: North | Eggers & Reed: | | |
| Upland | | | |
