WETLAND DETERMINATION DATA FORM - North Central and Northeast Region

Project/Site: SPP City/County: Aitkin Sampling Date: 2016-08-29
 Applicant/Owner: Enbridge State: Minnesota Sampling Point: w-47n22w11-aa1
 Investigator(s): DPT, MGH Section, Township, Range: S11, T47N, R22W
 Landform (hillslope, terrace, etc.): Depression Local Relief (concave, convex, none): CL Slope (%): 0-2%
 Subregion (LRR or MLRA): _____ Latitude: 46.568627120039 Longitude: -93.07926504... Datum: NAD83
 Soil Map Unit Name: 736 NWI Classification: N/A
 Are climatic/hydrologic conditions on the site typical for this time of year? (if no, explain in Remarks): No
 Are Vegetation No, Soil No, or Hydrology No significantly disturbed? Are "Normal Circumstances" present? Yes
 Are Vegetation No, Soil No, or Hydrology No naturally problematic? (If needed, explain any answers in Remarks)

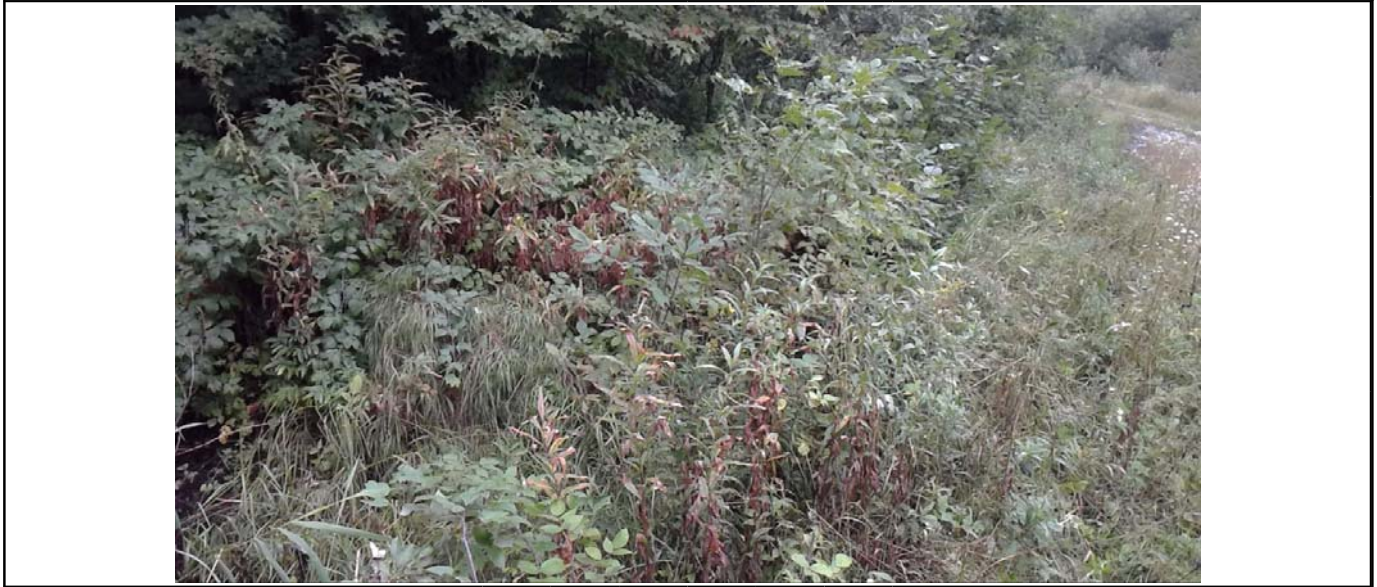
Site Photograph 1

Sampling Point: w-47n22w11-aa1

Cowardin Classification: PSS

Direction: north

Eggers & Reed: Shrub-Carr/Alder Thicket

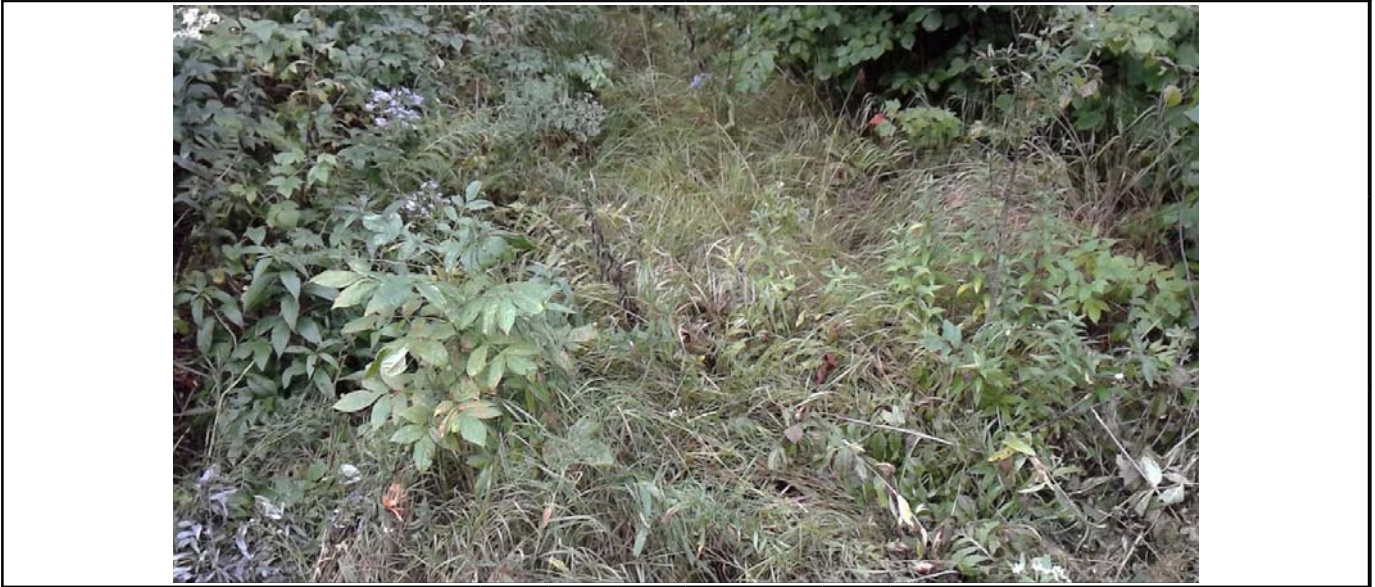
Site Photograph 2

Sampling Point: w-47n22w11-aa1

Cowardin Classification: PSS

Direction: west

Eggers & Reed: Shrub-Carr/Alder Thicket
