## WETLAND DETERMINATION DATA FORM - North Central and Northeast Region

| Project/Site: SPP | City/County: Aitkin | | Sampling Date: 2016-08-29 | | | |
| Applicant/Owner: Enbridge | State: Minnesota Sampling Point: w-47n22w11-ab1 | | | | | |

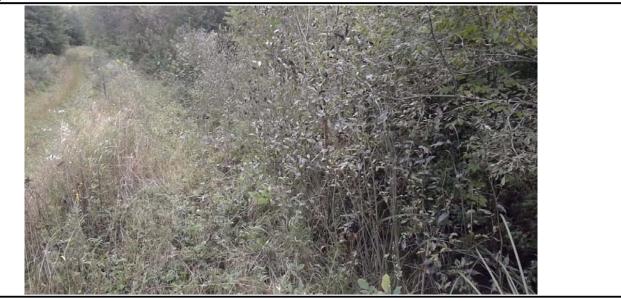
Site Photograph 1 Sampling Point: w-47n22w11-ab1

| Latitude: 46.5685702907355 | Cowardin Classification: PSS | |
| Longitude: -93.0791837443533 | Circular 39: 6 | |
| Direction: north | Eggers & Reed: Shrub-Carr/Alder Thicket | |

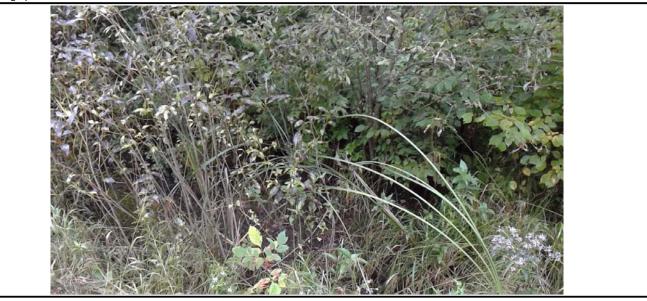
Site Photograph 2 Sampling Point: w-47n22w11-ab1

| Latitude: 46.5685699135499 | Cowardin Classification: PSS |
| Longitude: -93.0791830738011 | Circular 39: 6 |
| Direction: east | Eggers & Reed: Shrub-Carr/Alder Thicket |
