## WETLAND DETERMINATION DATA FORM - North Central and Northeast Region

Project/Site: SPP	City/County: Aitkin		Sampling Date: 2016-08-29
Applicant/Owner: Enbridge		State: Minnesota	Sampling Point: w-47n22w11-ac1
Investigator(s): DPT, MGH	Section, Towns	hip, Range: S11, T47N, R22W	· • • • • • • • • • • • • • • • • • • •
Landform (hillslope, terrace, etc.): Depre		Local Relief (concave, convex	s, none): CL Slope (%): 0-2%
Subregion (LRR or MLRA):		,	le: -93.08191071 Datum: NAD83
Soil Map Unit Name: 166			NWI Classification: N/A
Are climatic/hydrologic conditions on the	e site typical for this time of ye	ar? (if no explain in Remarks):	No
Are Vegetation No_, Soil No_, or Hyd	drology No significantly distu	irbed? Are "Normal Circumstan	ces" present? Yes
Are Vegetation No_, Soil No_, or Hydro	ology No naturally problema	tic? (If needed, explain any ans	swers in Remarks)
· — — ·			,
SUMMARY OF FINDINGS - Attach site	map showing sampling point	locations, transects, important	features, etc.

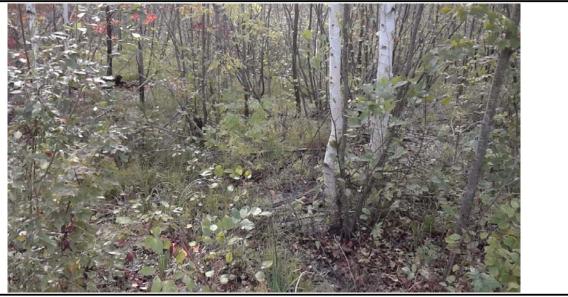
Site Photograph 1 Sampling Point: w-47n22w11-ac1

Latitude: 46.5661682468341	Cowardin Classification: PSS
Longitude: -93.0818913505348	Circular 39: 6
Direction: east	Eggers & Reed: Shrub-Carr/Alder Thicket

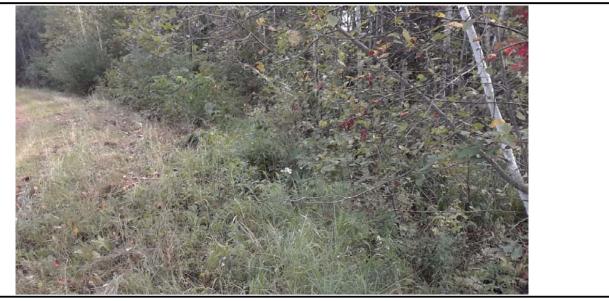
Site Photograph 2 Sampling Point: w-47n22w11-ac1

Latitude: 46.5661668219106	Cowardin Classification: PSS	
Longitude: -93.0818684679392	Circular 39: 6	
Direction: north	Eggers & Reed: Shrub-Carr/Alder Thicket	
Remarks:
