WETLAND DETERMINATION DATA FORM - North Central and Northeast Region

Project/Site: SPP City/County: Aitkin Sampling Date: 2016-08-29
 Applicant/Owner: Enbridge State: Minnesota Sampling Point: w-47n22w11-ac2
 Investigator(s): DPT, MGH Section, Township, Range: S11, T47N, R22W
 Landform (hillslope, terrace, etc.): Depression Local Relief (concave, convex, none): CL Slope (%): 0-2%
 Subregion (LRR or MLRA): _____ Latitude: 46.5662025288... Longitude: -93.08194650... Datum: NAD83
 Soil Map Unit Name: 166 NWI Classification: N/A
 Are climatic/hydrologic conditions on the site typical for this time of year? (if no, explain in Remarks): No
 Are Vegetation No, Soil No, or Hydrology No significantly disturbed? Are "Normal Circumstances" present? Yes
 Are Vegetation No, Soil No, or Hydrology No naturally problematic? (If needed, explain any answers in Remarks)

Site Photograph 1

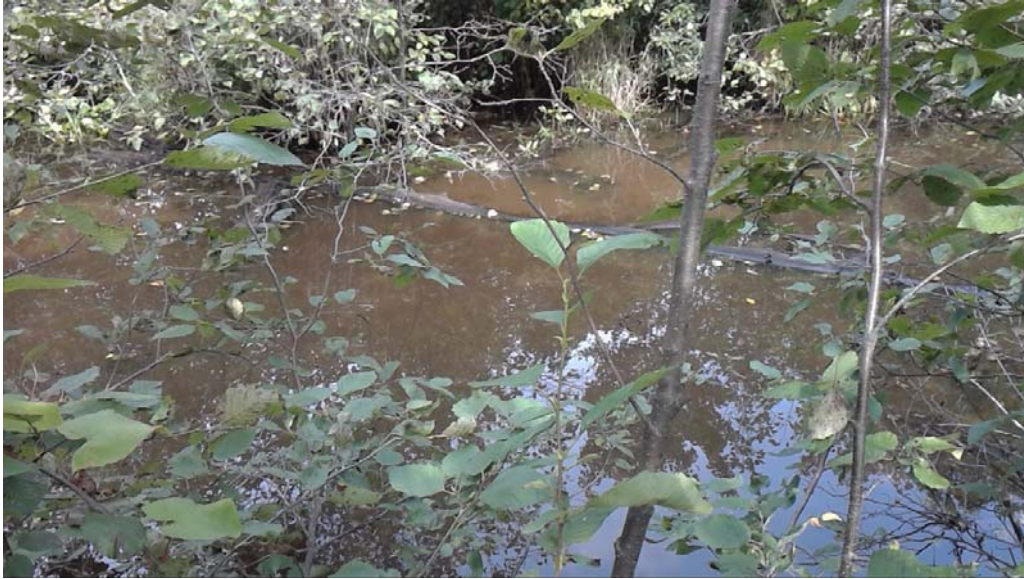
Latitude: 46.5662113298164

Cowardin Classification: PUB

Longitude: -93.0819557235512

Circular 39: 5

Direction: west

Eggers & Reed: Shallow, Open Water

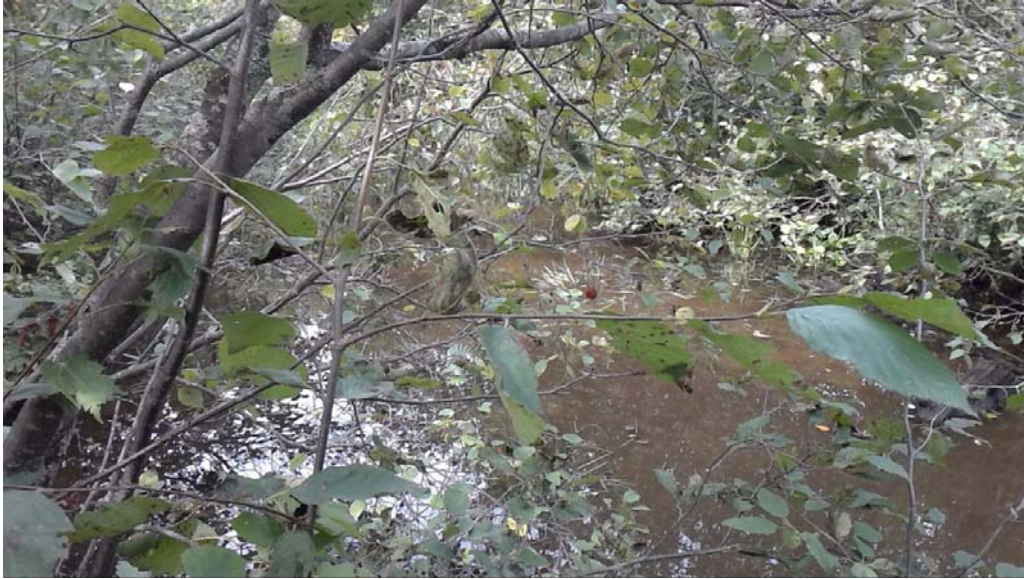
Latitude: 46.5662144311206

Cowardin Classification: PUB

Longitude: -93.081963267264

Circular 39: 5

Direction: south

Eggers & Reed: Shallow, Open Water
