WETLAND DETERMINATION DATA FORM - North Central and Northeast Region

Project/Site: SPP	c	ity/County: Aitkin		Sampling Date: 2016-08-29			
Applicant/Owner: Enbridge			State: Minnesota	Samplii	ng Point: <u>w-47n22w11-ad1</u>		
Investigator(s): DPT, MGG Section, Township, Range: S11, T47N, R22W							
Landform (hillslope, terrace, etc.):	Depression		Local Relief (concave, cor	nvex, none): CL	Slope (%): 0-2%		
Subregion (LRR or MLRA):		 Latitude: 46	5.5648270585 Long	itude: -93.08447473	Datum: NAD83		
Soil Map Unit Name: 736		_		NWI Cla	ssification: N/A		
Are climatic/hydrologic conditions on the site typical for this time of year? (if no, explain in Remarks): No							
Are Vegetation No , Soil No , or Hydrology No significantly disturbed? Are "Normal Circumstances" present? Yes							
Are Vegetation No_, Soil No_, or Hydrology No_ naturally problematic? (If needed, explain any answers in Remarks)							
SUMMARY OF FINDINGS - Attac	ch site map sho	wing sampling point lo	cations, transects, import	tant features, etc.

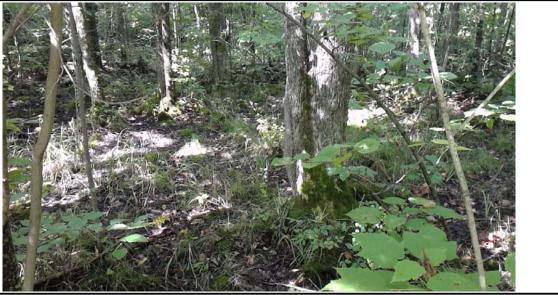
Site Photograph 1 Sampling Point: w-47n22w11-ad1

Latitude: 46.5648424393	Cowardin Classification: PFO			
Longitude: -93.0844831188145	Circular 39: 1			
Direction: west	Eggers & Reed: Seasonally Flooded Basin			
Remarks:

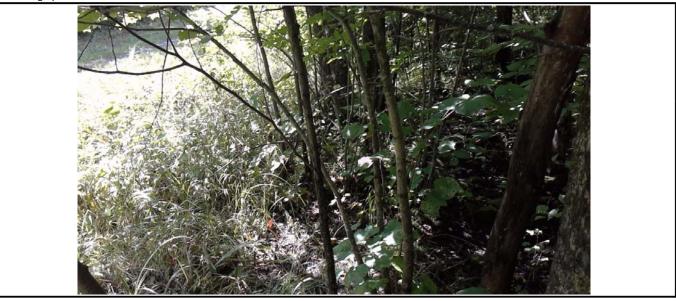
Site Photograph 2 Sampling Point: w-47n22w11-ad1

Latitude: 46.5648522461267	Cowardin Classification: PFO
Longitude: -93.0844884832325	Circular 39: 1
Direction: south	Eggers & Reed: Seasonally Flooded Basin
Remarks:
