## WETLAND DETERMINATION DATA FORM - North Central and Northeast Region

Project/Site: SPP	City/County: Aitkin		Sampling Date: 2016-08-29	
Applicant/Owner: Enbridge		State: Minnesota	Sampling Point: w-47n22w14-ac1	
Investigator(s): DPT, MGH	Section, Towns	hip, Range: S14, T47N, R22W		
Landform (hillslope, terrace, etc.): Depres		Local Relief (concave, convex	x, none): CL Slope (%): 0-2%	
Subregion (LRR or MLRA):		,	de: -93.09109702 Datum: NAD83	
Soil Map Unit Name: 166			NWI Classification: N/A	
Are climatic/hydrologic conditions on the	site typical for this time of ve	ar? (if no explain in Remarks):	No	
Are Vegetation No , Soil No , or Hyd	rology No significantly distu	ırbed? Are "Normal Circumstar	nces" present? Yes	
Are Vegetation No , Soil No , or Hydro	logy No naturally problema	tic? (If needed, explain any an	swers in Remarks)	
· ·		, , , , , ,	,	
SUMMARY OF FINDINGS - Attach site	map showing sampling point	locations, transects, important	t features, etc.	
Hydrophytic Vegetation Present?	<u>Yes</u>	Is the Sampled Area

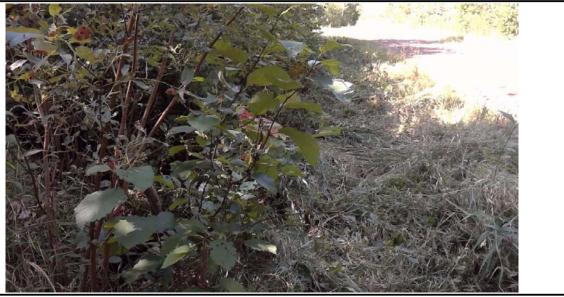
Site Photograph 2 Sampling Point: w-47n22w14-ac1

Latitude:	46.5580678917901	Cowardin Classification: PSS
Longitude:	-93.0910956860456	Circular 39: 6
Direction: nort	ch	Eggers & Reed: Shrub-Carr/Alder Thicket
Remarks:
