## WETLAND DETERMINATION DATA FORM - North Central and Northeast Region

Project/Site: SPP	City/Cou	City/County: Aitkin		Sampling Date: 2016-08-30		
Applicant/Owner: Enbridge			State: Minnesota	Sampli	ng Point: <u>w-47n22w14-ae1</u>	
Investigator(s): DPT, MGH	S	ection, Township	o, Range: S14, T47N, R22	W		
Landform (hillslope, terrace, etc.):	epression		Local Relief (concave, co	nvex, none): CC	Slope (%): 0-2%	
Subregion (LRR or MLRA):		 Latitude: 46.	.557171614884 Long	gitude: -93.09004065	Datum: NAD83	
Soil Map Unit Name: 152C				NWI Cla	assification: N/A	
Are climatic/hydrologic conditions of	n the site typical for t	his time of year?	(if no, explain in Remark		No	
, ,		,		,		
Are Vegetation No , Soil No , o	r Hydrology NO sigr	nificantly disturb	ed? Are "Normal Circum	istances" present? Yes	_	
Are Vegetation No_, Soil No_, or	Hydrology <u>No</u> natur	ally problematic	? (If needed, explain an	y answers in Remarks)		
CLIMANA DV OF FINIDINGS AND						
SUMMARY OF FINDINGS - Attack	n site map showing sa Yes	mpling point loc		tant features, etc.

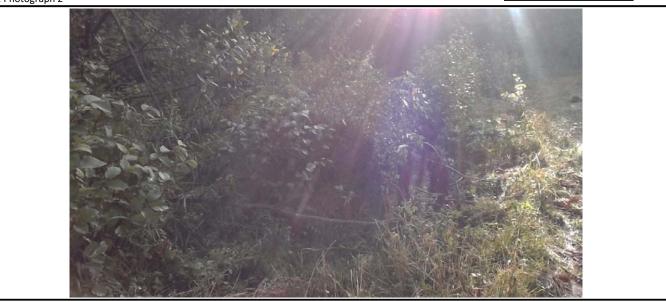
Site Photograph 2 Sampling Point: w-47n22w14-ae1

Latitude: 46.5570169687705	Cowardin Classification: PSS
Longitude: -93.0889935047301	Circular 39: 6
Direction: south	Eggers & Reed: Shrub-Carr/Alder Thicket
Remarks:
