WETLA	ND DETERMINATION DA	TA FORM - North Central a	and Northeast Region		
Project/Site: SPP	City/County: <u>Aitkin</u>		Samplin	g Date: 2016-08-30	
Applicant/Owner: Enbridge		State: Minnesota	Samplin	g Point: <u>w-47n22w14-ag1</u>	
Investigator(s): DPT, MGH	Section, Tow	nship, Range: S14, T47N, R22	W		
Landform (hillslope, terrace, etc.): Depres	ssion	Local Relief (concave, cor	nvex, none): <u>CL</u>	Slope (%): <u>0-2%</u>	
Subregion (LRR or MLRA):	Latitud	e: 46.5504433773 Long	gitude: <u>-93.08218035</u>	Datum: NAD83	
Soil Map Unit Name: 533			NWI Clas	sification: PSSB	
Are climatic/hydrologic conditions on the	e site typical for this time of	year? (if no, explain in Remark	<s):< td=""><td>No</td></s):<>	No	
Are Vegetation <u>No</u> , Soil <u>No</u> , or Hyd	drology <u>No</u> significantly di	sturbed? Are "Normal Circum	stances" present? Yes		
Are Vegetation <u>No</u> , Soil <u>No</u> , or Hydro	ology <u>No</u> naturally problem	matic? (If needed, explain any	y answers in Remarks)

SUMMARY OF FINDINGS - Attach site	map showing sampling poi	nt locations, transects, impor	tant features, etc.		
Hydrophytic Vegetation Present?	Yes	Is the Sampled Area			
Hydric Soil Present?	Yes	withi

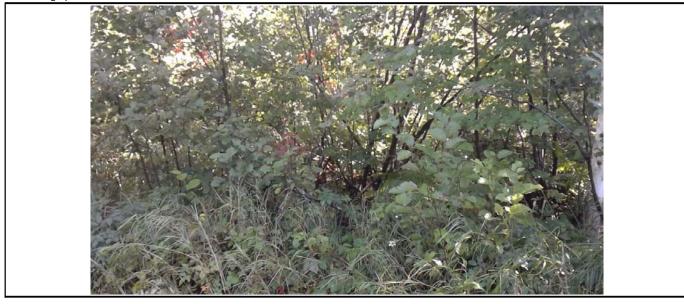
Site Photograph 1

Cowardin Classification: PSS

Circular 39: 6

Direction: east

Eggers & Reed: Shrub-Carr/Alder Thicket

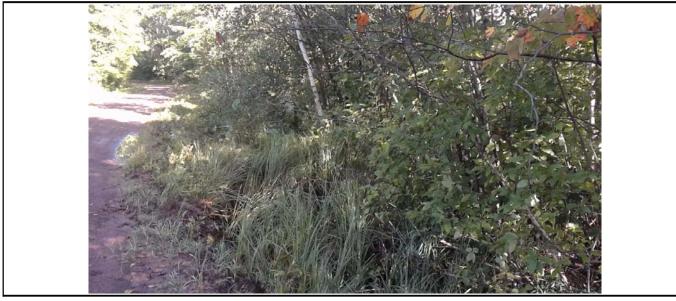
Site Photograph 2

Cowardin Classification: PSS

Circular 39: 6

Direction: north

Eggers & Reed: Shrub-Carr/Alder Thicket
