## WETLAND DETERMINATION DATA FORM - North Central and Northeast Region

Project/Site: SPP	City/County: Aitkin		Sampling Date: 2016-08-30			
Applicant/Owner: Enbridge		State: Minnesota	Samplin	g Point: <u>w-47n22w23-aa1</u>		
Investigator(s): DPT, MGH	Section, Townshi	ip, Range: S23, T47N, R22\	N			
Landform (hillslope, terrace, etc.): Depression		Local Relief (concave, cor	ivex, none): CC	Slope (%): 0-2%		
Subregion (LRR or MLRA):	 Latitude: 40	6.5435471246 Long	itude: -93.07885006	Datum: NAD83		
Soil Map Unit Name: 166	_		NWI Clas	ssification: N/A		
Are climatic/hydrologic conditions on the site t	vpical for this time of year	? (if no. explain in Remark:	s):	No		
Are Vegetation No_, Soil No_, or Hydrology No_ significantly disturbed? Are "Normal Circumstances" present? Yes_  Are Vegetation No_, Soil No_, or Hydrology No_ naturally problematic? (If needed, explain any answers in Remarks)						
SUMMARY OF FINDINGS - Attach site map	showing sampling point lo	ocations, transects, import	ant features, etc.

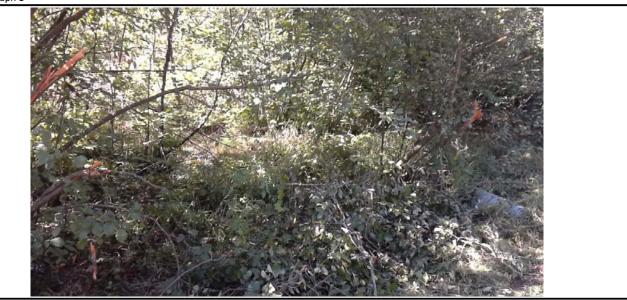
Site Photograph 1 Sampling Point: w-47n22w23-aa1

Latitude: 46.5435395809324	Cowardin Classification: PSS
Longitude: -93.0788554252061	Circular 39: 6
Direction: west	Eggers & Reed: Shrub-Carr/Alder Thicket
Remarks:
