WETLAND DETERMINATION DATA FORM - North Central and Northeast Region

Project/Site: SPP	City/County: Aitkin		Sampling Date: 2016-08-30		
Applicant/Owner: Enbridge		State: Minnesota	Samplir	ng Point: w-47n22w24-aa1	
Investigator(s): DPT, MGH	Section. Towr	nship, Range: S24, T47N, R22			
Landform (hillslope, terrace, etc.): Depre		Local Relief (concave, co		Slope (%): 0-2%	
Subregion (LRR or MLRA):		•	gitude: -93.07445433	Datum: NAD83	
Soil Map Unit Name: 164B				ssification: N/A	
Are climatic/hydrologic conditions on the	e site typical for this time of v	ear? (if no. explain in Remarl		No No	
			·		
Are Vegetation No_, Soil No_, or Hy	drology No significantly dis	turbed? Are "Normal Circum	nstances" present? Yes		
Are Vegetation No , Soil No , or Hydr	ology No naturally problem	atic? (If needed, explain an	y answers in Remarks)		
SUMMARY OF FINDINGS - Attach site	map showing sampling poin	t locations, transects, impo	rtant features, etc.		
Hydrophytic Vegetation Present?	Yes	Is the Sampled Area

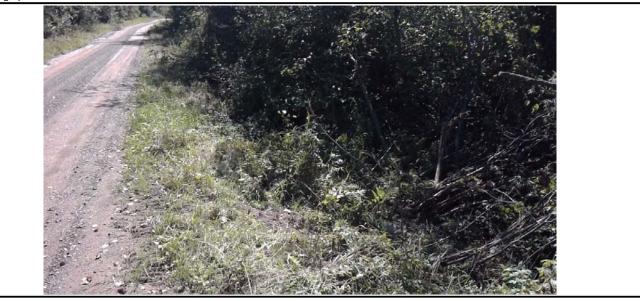
Site Photograph 2 Sampling Point: w-47n22w24-aa1

Latitude: 46.5409094654457	Cowardin Classification: PSS		
Longitude: -93.0744542554888	Circular 39: 6		
Direction: south	Eggers & Reed: Shrub-Carr/Alder Thicket		
Remarks:
