WETLAND DETERMINATION DATA FORM - North Central and Northeast Region

Site Photograph 1 Sampling Point: w-47n22w24-ab1

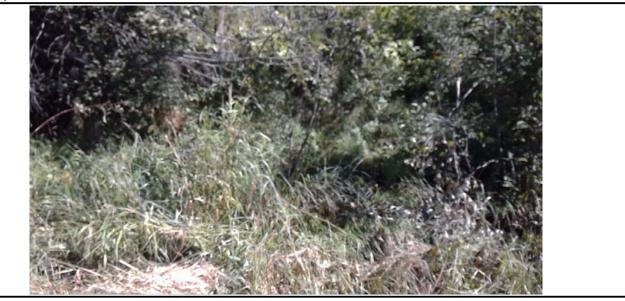
The state of the s		
Latitude: 46.5408956353055	Cowardin Classification: PSS	
Longitude: -93.0742799119028	Circular 39: 6	
Direction: east	Eggers & Reed: Shrub-Carr/Alder Thicket	
Remarks:

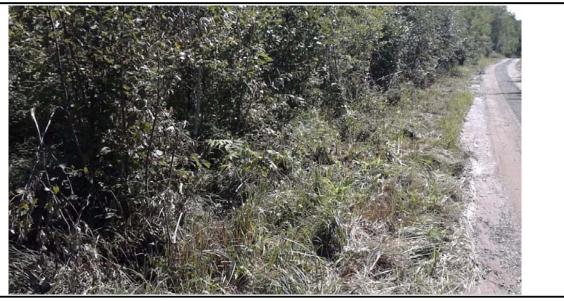
Site Photograph 2 Sampling Point: w-47n22w24-ab1

Latitude: 46.5408960124911	Cowardin Classification: PSS			
Longitude: -93.0742806662741	Circular 39: 6			
Direction: south	Eggers & Reed: Shrub-Carr/Alder Thicket			
Remarks:
