WETLAND DETERMINATION DATA FORM - North Central and Northeast Region

Project/Site: SPP	City/County: Aitkin		Sampling Date: 2016-08-30		
Applicant/Owner: Enbridge		State: Minnesota	Sampling Point: w-47n22w24-ac1		
Investigator(s): DPT, MGH	Section, Townsh	ip, Range: S24, T47N, R22W			
Landform (hillslope, terrace, etc.): Depression		Local Relief (concave, convex	, none): CL Slope (%): 0-2%		
Subregion (LRR or MLRA):	Latitude: 4	6.5389773110 Longitud	e: -93.07245475 Datum: NAD83		
Soil Map Unit Name: 544			NWI Classification: PFO/SS1C		
Are climatic/hydrologic conditions on the site	typical for this time of year	r? (if no, explain in Remarks):	No		
Are Vegetation No , Soil No , or Hydrology No significantly disturbed? Are "Normal Circumstances" present? Yes					
Are Vegetation No, Soil No, or Hydrology No naturally problematic? (If needed, explain any answers in Remarks)					
SUMMARY OF FINDINGS - Attach site map	showing sampling point l	ocations, transects, important	features, etc.

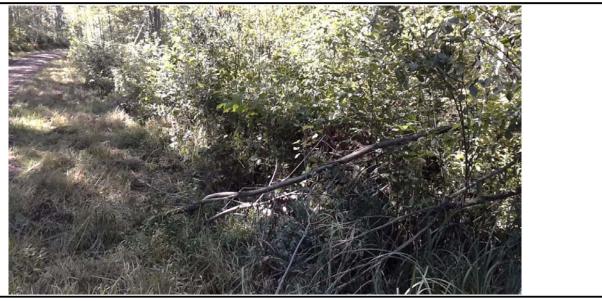
Site Photograph 1 Sampling Point: w-47n22w24-ac1

Latitude: 46.5389773110361	Cowardin Classification: PSS			
Longitude: -93.0724547524872	Circular 39: 6			
Direction: south	Eggers & Reed: Shrub-Carr/Alder Thicket			
Romarks
