WETLAND DETERMINATION DATA FORM - North Central and Northeast Region

Project/Site: SPP	City,	/County: Aitkin		Sampling Date: 2016-08-22		
Applicant/Owner: Enbridge			State: Minnesota	Samplir	ng Point: <u>w-50n26w17-aa1</u>	
Investigator(s): ZCW, MGH		_ Section, Township	p, Range: <u>\$17, T50N, 26</u> \	W		
Landform (hillslope, terrace, etc.): Depres	sion		Local Relief (concave, co	onvex, none): CC	Slope (%): 0-2%	
Subregion (LRR or MLRA):		 Latitude: 46	i.8200278887 Lon	ngitude: -93.67675895	Datum: NAD83	
Soil Map Unit Name: 928C				NWI Cla	ssification: N/A	
Are climatic/hydrologic conditions on the	site typical	for this time of year	? (if no, explain in Remar		No	
. , .	• •	,		,		
Are Vegetation No , Soil No , or Hyd	irology <u>ivo</u>	_ significantly disturb	ded! Ale Normal Circuit	listances present: 163		
Are Vegetation No , Soil No , or Hydro	ology <u>No</u> n	aturally problemation	? (If needed, explain ar	ny answers in Remarks)		
SUMMARY OF FINDINGS - Attach site	map showir	ng sampling point lo	cations, transects, impo	rtant features, etc.

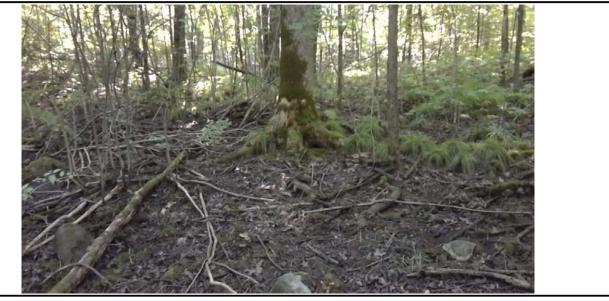
Site Photograph 1 Sampling Point: w-50n26w17-aa1

Latitude: 46.8199894996796	Cowardin Classification: PFO				
Longitude: -93.6767468043544	Circular 39: 1				
Direction: South	Eggers & Reed: Seasonally Flooded Basin				
Remarks:

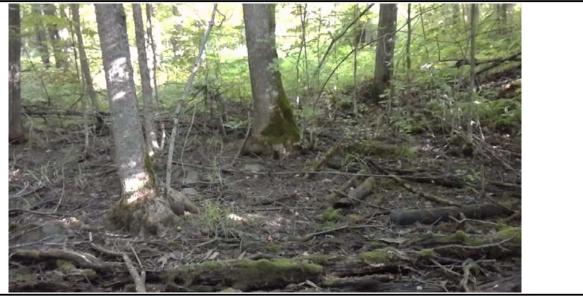
Site Photograph 2 Sampling Point: w-50n26w17-aa1

Cowardin Classification: PFO			
Circular 39: 1			
Eggers & Reed: Seasonally Flooded Basin
