WETLAND DETERMINATION DATA FORM - North Central and Northeast Region

Project/Site: SPP	c	ity/County: Aitkin		Samp	ling Date: 2016-08-23
Applicant/Owner: Enbridge			State: Minnesota	Sampl	ing Point: w-50n26w17-ae1
Investigator(s): ZCW, MGH		Section, Townshi	p, Range: S18, T50N, R26	5W	
Landform (hillslope, terrace, etc.): Depre	ession		Local Relief (concave, co	nvex, none): CC	Slope (%): 0-2%
Subregion (LRR or MLRA):		 Latitude: 46	i.8194240984 Lon	gitude: -93.67703732	. Datum: NAD83
Soil Map Unit Name: 928C				NWI C	assification: N/A
Are climatic/hydrologic conditions on th	e site typic	cal for this time of year	? (if no. explain in Remarl		No
Are Vegetation No , Soil No , or Hy Are Vegetation No , Soil No , or Hydr					
SUMMARY OF FINDINGS - Attach site	e map show	wing sampling point lo	cations, transects, impo	rtant features, etc.	
Hydrophytic Vegetation Present?		Yes	Is the Sampled Area		
Hydric Soil Present?		Yes	within a Wetland?		Yes
Wetland Hydrology Present?		Yes	If yes, optional Wetland	Site ID:	w-50n26w18-ai

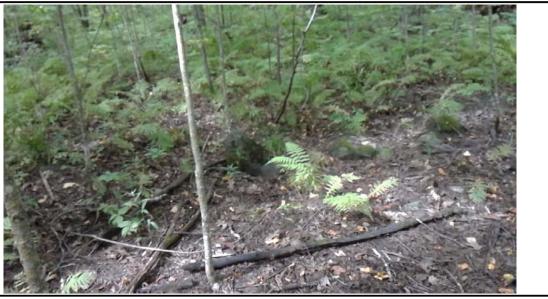
Site Photograph 1 Sampling Point: w-50n26w17-ae1

Latitude: 46.8194092624325	Cowardin Classification: PSS
Longitude: -93.6770266761013	Circular 39: 1
irection: North	Eggers & Reed: Seasonally Flooded Basin
emarks:
