WETL	AND DETE	RMINATION DATA F	ORM - North Central	and Northeast	Region		
Project/Site: SPP	Ci	City/County: Aitkin			Sampling Date:	2016-08-24	
Applicant/Owner: Enbridge			State: Minnesota		Sampling Point:	w-50n26w17-af1	
Investigator(s): ZCW, MGH		Section, Townshi	p, Range: <u>S17, T50N, R2</u>	26W			
Landform (hillslope, terrace, etc.): Depr	ession		Local Relief (concave, c	convex, none): <u>CC</u>		Slope (%): <u>0-2%</u>	
Subregion (LRR or MLRA):		Latitude: 46	5.8160711694 Lo	ngitude: <u>-93.6763</u>		um: NAD83	
Soil Map Unit Name: 204B					NWI Classificatio	n: <u>N/A</u>	
Are climatic/hydrologic conditions on th	ne site typic	al for this time of year	? (if no, explain in Rema	irks):		No	
Are Vegetation No_, Soil No, or Hydrology No_ significantly disturbed? Are "Normal Circumstances" present? Yes							
Are Vegetation <u>No</u> , Soil <u>No</u> , or Hydrology <u>No</u> naturally problematic? (If needed, explain any answers in Remarks)

Sampling Point: w-50n26w...

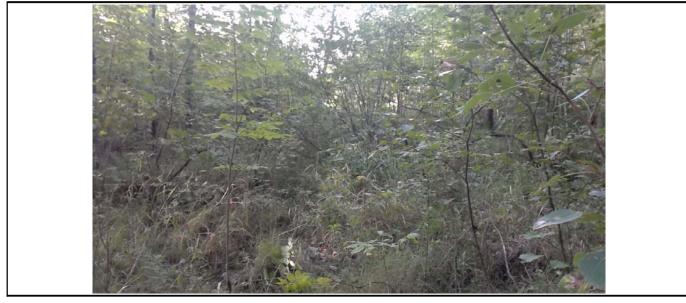
Site Photograph 1

Latitude: 46.8160615303058

Longitude: -93.676402224315

Cowardin Classification: PSS

Circular 39: 6

Direction: South

Eggers & Reed: Shrub-Carr/Alder Thicket

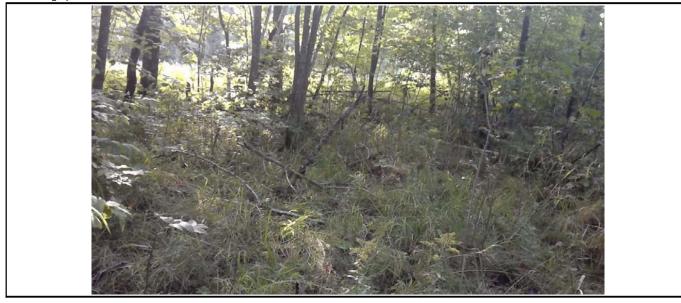
Site Photograph 2

Sampling Point: w-50n26w17-af1

Latitude: 46.81606203322

Longitude: -93.6764029786863

Cowardin Classification: <u>PSS</u> Circular 39: <u>6</u>

Direction: East Remarks:

Eggers & Reed: Shrub-Carr/Alder Thicket
