WETLAND DETERMINATION DATA FORM - North Central and Northeast Region

Project/Site: SPP	Ci	ity/County: Aitkin		Samplir	ng Date: 2016-08-24		
Applicant/Owner: Enbridge			State: Minnesota	Samplin	ng Point: w-50n26w17-ai1		
Investigator(s): ZCW, MGH		Section, Township	p, Range: <u>S17, T50N, R2</u>	6W			
Landform (hillslope, terrace, etc.): Depres	ssion		Local Relief (concave, co	onvex, none): CL	Slope (%): 0-2%		
Subregion (LRR or MLRA):		Latitude: 46	i.8159273360 Lor	ngitude: -93.67608119	Datum: NAD83		
Soil Map Unit Name: 204B		_		NWI Cla	ssification: N/A		
Are climatic/hydrologic conditions on the	site typic	al for this time of year	? (if no, explain in Remar	rks):	No		
Are Vegetation No , Soil No , or Hydrology No significantly disturbed? Are "Normal Circumstances" present? Yes							
Are Vegetation No_, Soil No_, or Hydrology No_ naturally problematic? (If needed, explain any answers in Remarks)							
SUMMARY OF FINDINGS - Attach site	map shov	ving sampling point lo	cations, transects, impo	ortant features, etc.

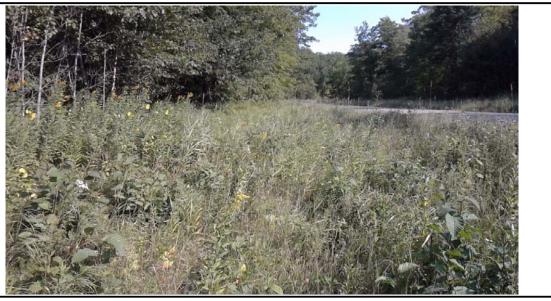
Site Photograph 1 Sampling Point: w-50n26w17-ai1

点。在一种的一种的一种,一种一种的一种,一种一种的一种,一种一种的一种,一种一种一种一种
Latitude: 46.8159273360361	Cowardin Classification: PEM
Longitude: -93.6760811136045	Circular 39: 2
Direction: North	Eggers & Reed: Fresh (Wet) Meadow
Pomarke:

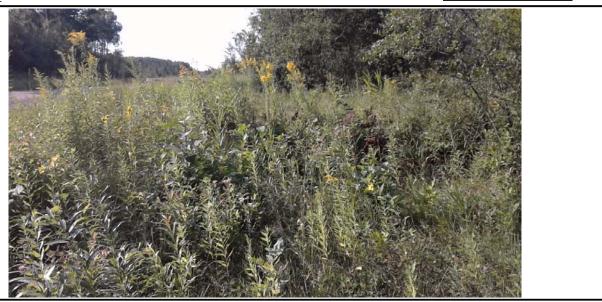
Site Photograph 2 Sampling Point: w-50n26w17-ai1

Cowardin Classification: PEM				
Circular 39: 2				
Eggers & Reed: Fresh (Wet) Meadow
