WETLAND DETERMINATION DATA FORM - North Central and Northeast Region

Project/Site: SPP	City/County: Aitkin		Sampling Date: 2016-08-24			
Applicant/Owner: Enbridge		State: Minnesota	Sampling Point: w-50n26w17-aj1			
Investigator(s): ZCW, MGH	Section, Townshi	p, Range: S17, T50N, R26W				
Landform (hillslope, terrace, etc.): Depression	<u> </u>	Local Relief (concave, conv	ex, none): CL Slope (%): 0-2%			
Subregion (LRR or MLRA):	 Latitude: 46	•	ude: -93.67586687 Datum: NAD83			
Soil Map Unit Name: 204B	_		NWI Classification: N/A			
Are climatic/hydrologic conditions on the site ty	oical for this time of vear	? (if no. explain in Remarks)

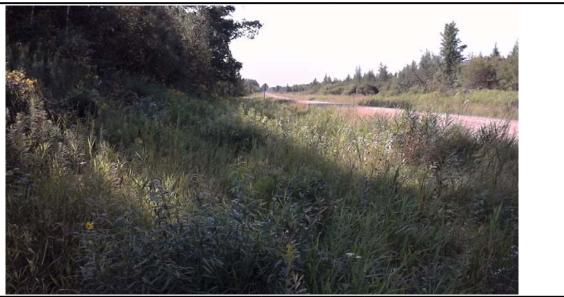
Site Photograph 1 Sampling Point: w-50n26w17-aj1

Latitude: 46.8156113382865	Cowardin Classification: PEM		
Longitude: -93.675841977907	Circular 39: 2		
virection: South	Eggers & Reed: Fresh (Wet) Meadow		
marks:

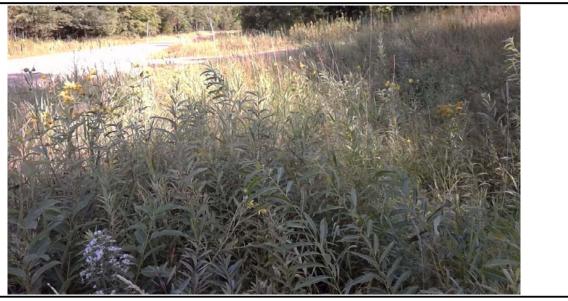
Site Photograph 2 Sampling Point: w-50n26w17-aj1

Latitude:	46.8156114221055	Cowardin Classification: PEM
Longitude:	-93.6758416426309	Circular 39: 2
Direction: North		Eggers & Reed: Fresh (Wet) Meadow
Remarks:
