## WETLAND DETERMINATION DATA FORM - North Central and Northeast Region

Project/Site: SPP	City/County: Aitkin		Sampling Date: 2016-08-19		
Applicant/Owner: Enbridge		State: Minnesota	Sampling Point: w-50n26w18-a1		
Investigator(s): ZCW, MGH	Section, Townshi	p, Range: S18, T50N, R26W			
Landform (hillslope, terrace, etc.): Depression		Local Relief (concave, conve	ex, none): CC Slope (%): 0-2%		
Subregion (LRR or MLRA):	 Latitude: 46	,	ide: -93.68635305 Datum: NAD83		
Soil Map Unit Name: 1353B			NWI Classification: N/A		
Are climatic/hydrologic conditions on the site ty	nical for this time of year	? (if no explain in Remarks):			
Are Vegetation No , Soil No , or Hydrology	No significantly disturb	ped? Are "Normal Circumsta	inces" present? Yes		
Are Vegetation No , Soil No , or Hydrology N	o naturally problemati	c? (If needed, explain any a	nswers in Remarks)		
		, , , , ,	·		
SUMMARY OF FINDINGS - Attach site map s	nowing sampling point lo	cations, transects, importar	nt features, etc.

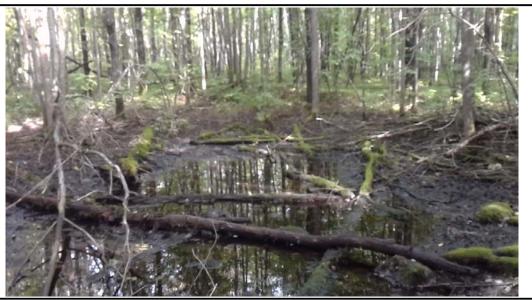
Site Photograph 1 Sampling Point: w-50n26w18-a1

Latitude: 46.8244928447966	Cowardin Classification: PFO		
Longitude: -93.6863626913109	Circular 39: 1		
Direction: North	Eggers & Reed: Seasonally Flooded Basin

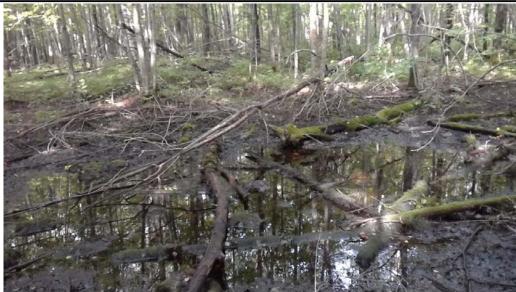
Site Photograph 2 Sampling Point: w-50n26w18-a1

2214 The Residence of the Control of				
Latitude:	46.8244928867061	Cowardin Classification: PFO		
Longitude:	-93.6863625236728	Circular 39: 1		
Direction: Wes	st	Eggers & Reed: Seasonally Flooded Basin		
Remarks:
