WETLAND DETERMINATION DATA FORM - North Central and Northeast Region

Project/Site: SPP City/County: Aitkin Sampling Date: 2016-08-23
 Applicant/Owner: Enbridge State: Minnesota Sampling Point: w-50n26w18-aa1
 Investigator(s): ZCW, MGH Section, Township, Range: S18, T50N, R26W
 Landform (hillslope, terrace, etc.): Depression Local Relief (concave, convex, none): CC Slope (%): 0-2%
 Subregion (LRR or MLRA): _____ Latitude: 46.8171368446... Longitude: -93.67969606... Datum: NAD83
 Soil Map Unit Name: 204B NWI Classification: N/A
 Are climatic/hydrologic conditions on the site typical for this time of year? (if no, explain in Remarks): No
 Are Vegetation No, Soil No, or Hydrology No significantly disturbed? Are "Normal Circumstances" present? Yes
 Are Vegetation No, Soil No, or Hydrology No naturally problematic? (If needed, explain any answers in Remarks)

Hydrophytic Vegetation Present?	<u>Yes</u>	Is the Sampled Area within a Wetland?	
Hydric Soil Present?	<u>Yes</u>		<u>Yes</u>
Wetland Hydrology Present?	<u>Yes</u>		If yes, optional Wetland Site ID: <u>w-50n26w18-aa</u>
Remarks: (Explain alternative procedures here or in a separate report.) Climatic conditions are "wet" based on th

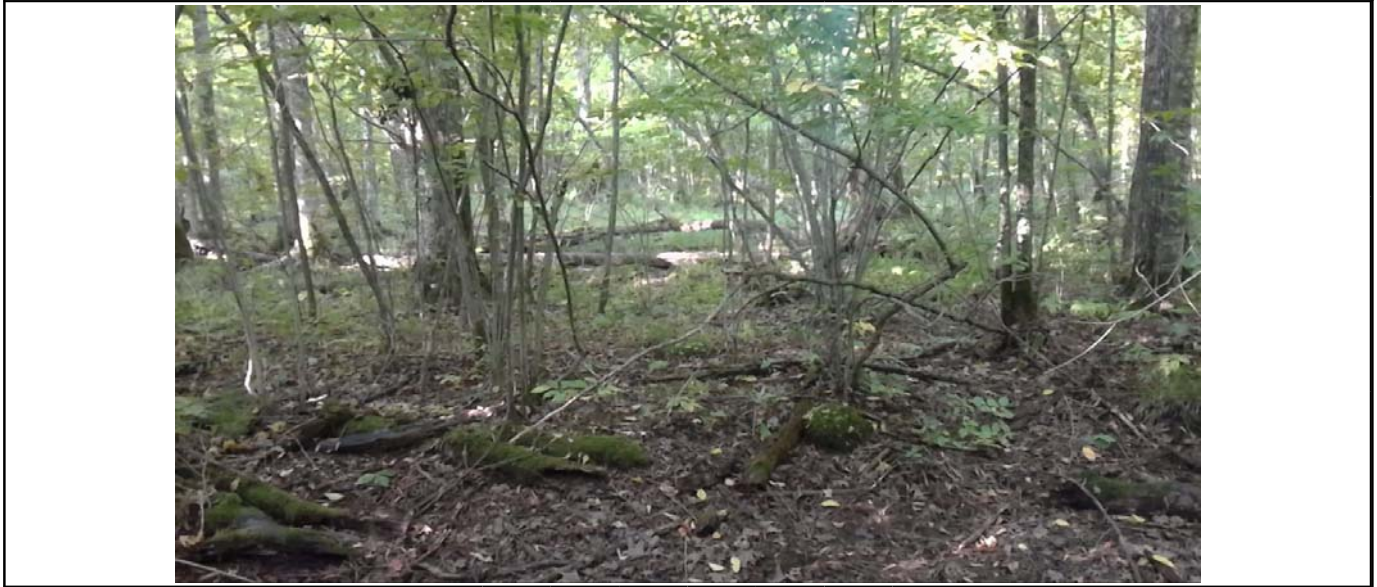
Site Photograph 1

Sampling Point: w-50n26w18-aa1

Cowardin Classification: PFO

Direction: South

Eggers & Reed: Seasonally Flooded Basin

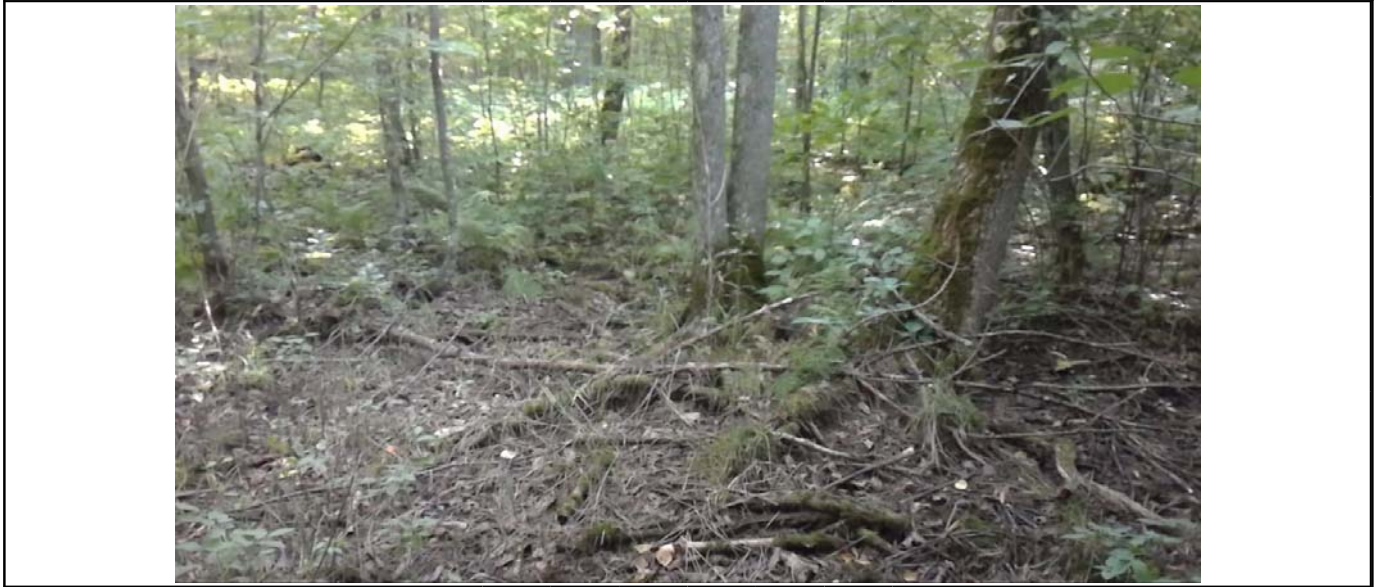
Site Photograph 2

Sampling Point: w-50n26w18-aa1

Cowardin Classification: PFO

Direction: North

Eggers & Reed: Seasonally Flooded Basin
