WETLAND DETERMINATION DATA FORM - North Central and Northeast Region

Project/Site: SPP	Ci	ity/County: Aitkin		Samplir	ng Date: 2016-08-23		
Applicant/Owner: Enbridge			State: Minnesota	Samplin	ng Point: w-50n26w18-ab1		
Investigator(s): ZCW, MGH		Section, Township	p, Range: <u>\$18,</u> T50N, R2	6W			
Landform (hillslope, terrace, etc.): Depres	ssion		Local Relief (concave, co	onvex, none): CC	Slope (%): 0-2%		
Subregion (LRR or MLRA):		Latitude: 46	i.8163544778 Lor	ngitude: -93.68012228	Datum: NAD83		
Soil Map Unit Name:				NWI Cla	ssification:		
Are climatic/hydrologic conditions on the	site typic	al for this time of year	? (if no, explain in Remai	•	No		
Are Vegetation No_, Soil No_, or Hyd	drology No	significantly disturb	ped? Are "Normal Circur	mstances" present? Yes			
Are Vegetation No_, Soil No_, or Hydro	ology <u>No</u>	_ naturally problematio	c? (If needed, explain a	ny answers in Remarks)			
SUMMARY OF FINDINGS - Attach site	map shov	ving sampling point lo	cations, transects, impo	ortant features, etc.

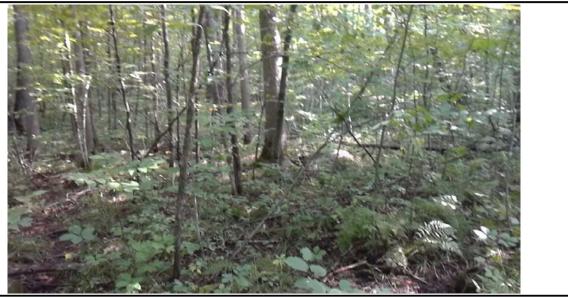
Site Photograph 1 Sampling Point: w-50n26w18-ab1

Latitude: 46.8163527595315	Cowardin Classification: PFO			
Longitude: -93.6801236216851	Circular 39: 7			
Direction: North	Eggers & Reed: Hardwood Swamp/Coniferous Swamp			
Remarks:

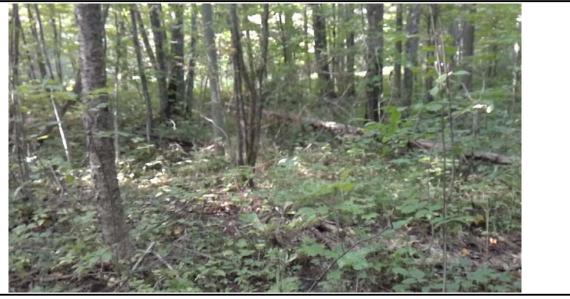
Site Photograph 2 Sampling Point: w-50n26w18-ab1

Cowardin Classification: PFO		
Circular 39: 7 Eggers & Reed: Hardwood Swamp/Coniferous Swamp
