## WETLAND DETERMINATION DATA FORM - North Central and Northeast Region

Project/Site: SPP	Cit	City/County: Aitkin		Sampling Date: 2016-08-23		
Applicant/Owner: Enbridge			State: Minnesota	Samplir	ng Point: w-50n26w18-ac1	
Investigator(s): ZCW, MGH		Section, Township	p, Range: <u>\$18, T50N, R26</u>	6W		
Landform (hillslope, terrace, etc.): Depres	ssion		Local Relief (concave, co	onvex, none): CC	Slope (%): 0-2%	
Subregion (LRR or MLRA):		Latitude: 46	5.8179005617 Lon	ngitude: -93.67868310	Datum: NAD83	
Soil Map Unit Name: 204B				NWI Cla	ssification: N/A	
Are climatic/hydrologic conditions on the	site typica	al for this time of year	? (if no, explain in Remar		No	
Are Vegetation No , Soil No , or Hydrology No significantly disturbed? Are "Normal Circumstances" present? Yes						
Are Vegetation No , Soil No , or Hydro	ology No	naturally problemation	? (If needed, explain ar	ny answers in Remarks)		
SUMMARY OF FINDINGS - Attach site	man chau	uing compling point lo	cations transacts impo	ertant faaturas, ats

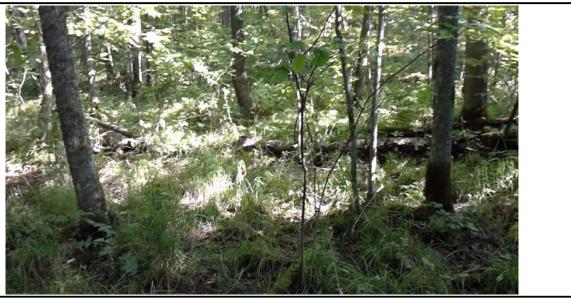
Site Photograph 1 Sampling Point: w-50n26w18-ac1

Cowardin Classification: PFO		
Longitude: _93.6786905676999	Circular 39: 1		
ection: North	Eggers & Reed: Seasonally Flooded Basin		
	Eggers & Need.		
rks:

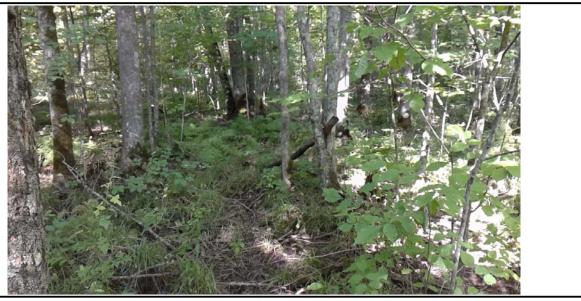
Site Photograph 2 Sampling Point: w-50n26w18-ac1

Latitude: 46.8179045012657	Cowardin Classification: PFO
Longitude: -93.6786717922368	Circular 39: 1
Direction: West	Eggers & Reed: Seasonally Flooded Basin
Remarks:
