WETLAND DETERMINATION DATA FORM - North Central and Northeast Region

Site Photograph 1 Sampling Point: w-50n26w18-ad1

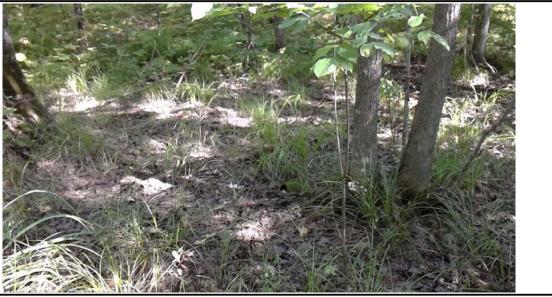
Latitude: 46.8181581376556	Cowardin Classification: PFO
Longitude: -93.679261710582	Circular 39: 1
Direction: North	Eggers & Reed: Seasonally Flooded Basin
Remarks:

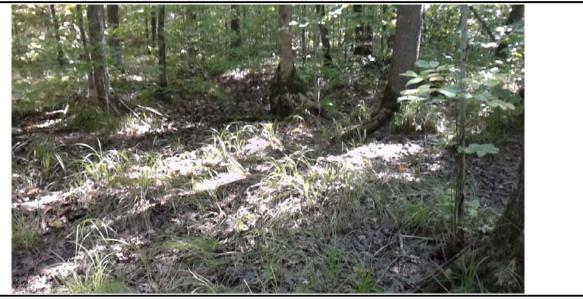
Site Photograph 2 Sampling Point: w-50n26w18-ad1

Latitude:	46.8181581795652	Cowardin Classification: PFO	
Longitude:	-93.6792615429439	Circular 39: 1	
Direction: East	t	Eggers & Reed: Seasonally Flooded Basin	
Remarks:
