## WETLAND DETERMINATION DATA FORM - North Central and Northeast Region

Site Photograph 1 Sampling Point: w-50n26w18-ae1

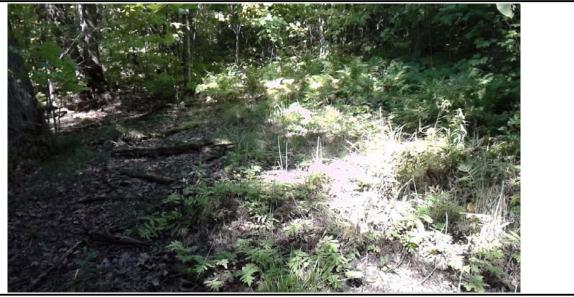
Latitude: 46.8185483571578	Cowardin Classification: PEM
Longitude: -93.6776987370976	Circular 39: 1
Direction: West	Eggers & Reed: Seasonally Flooded Basin
Remarks:

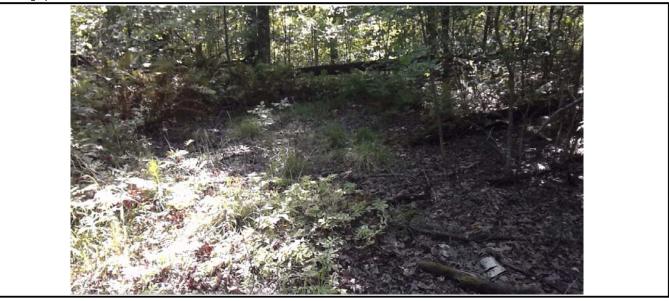
Site Photograph 2 Sampling Point: w-50n26w18-ae1

Latitude: 46.8185473513294	Cowardin Classification: PEM
Longitude: -93.6777000782021	Circular 39: 1
Direction: East	Eggers & Reed: Seasonally Flooded Basin
Remarks:
