WETL	AND DETERN	INATION DATA I	FORM - North Central	and Northeast Region	1			
Project/Site: SPP	City,	County: <u>Aitkin</u>		Sampling Date: 2016-08-23				
Applicant/Owner: Enbridge			State: Minnesota	Sampli	ng Point: <u>w-50n26w18-a</u>	əf1		
Investigator(s): ZCW, MGH		_ Section, Townshi	p, Range: <u>S18, T50N, R2</u>	6W				
Landform (hillslope, terrace, etc.): Depr	ression		Local Relief (concave, c	onvex, none): <u>CC</u>	Slope (%): <u>0-2</u> 9	%		
Subregion (LRR or MLRA):		Latitude: 46	5.8180088140 Loi	ngitude: -93.67806787	Datum: NAD83			
Soil Map Unit Name: 204B		_		NWI Cla	ssification: N/A			
Are climatic/hydrologic conditions on t	he site typical	for this time of year	? (if no, explain in Rema	rks):	No	_		
Are Vegetation <u>No</u> , Soil <u>No</u> , or H	ydrology <u>No</u>	significantly distur	bed? Are "Normal Circu	mstances" present? Yes	-			
Are Vegetation <u>No</u> , Soil <u>No</u> , or Hyd	lrology <u>No</u> n	aturally problemati	c? (If needed, explain a	ny answers in Remarks)

SUMMARY OF FINDINGS - Attach site map showing sampling point locations, transects, important features, etc.								
Hydrophytic Vegetation Present?	Ye	es	Is the Sampled Area					
Hydric Soil Presen

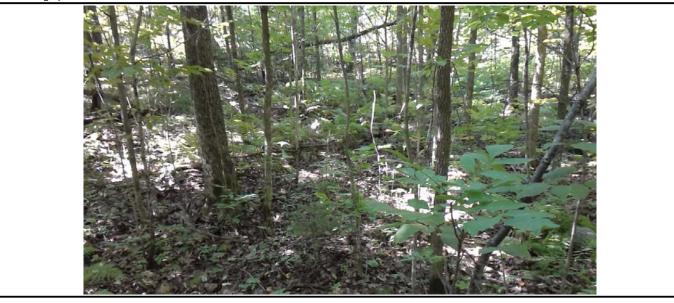
Site Photograph 1

Cowardin Classification: PFO

Circular 39: 1

Direction: North

Eggers & Reed: Seasonally Flooded Basin

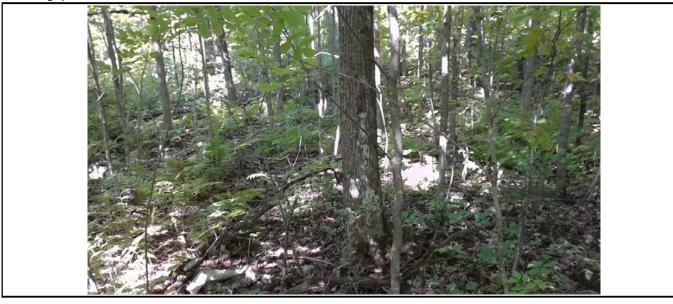
Site Photograph 2

Cowardin Classification: PFO

Circular 39: 1

Direction: West

Eggers & Reed: Seasonally Flooded Basin
