WETLAND DETERMINATION DATA FORM - North Central and Northeast Region

Project/Site: SPP	City/County: Aitkin		Sampling Date: 2016-08-23		
Applicant/Owner: Enbridge		State: Minnesota	Sampling Point: w-50n26w18-ag1		
Investigator(s): ZCW, MGH	Section, Townshi	p, Range: S18, T50N, R26W			
Landform (hillslope, terrace, etc.): Depression		Local Relief (concave, conve	ex, none): CC Slope (%): 0-2%		
Subregion (LRR or MLRA):	 Latitude: 46	•	ide: -93.67747762 Datum: NAD83		
Soil Map Unit Name: 204B			NWI Classification: N/A

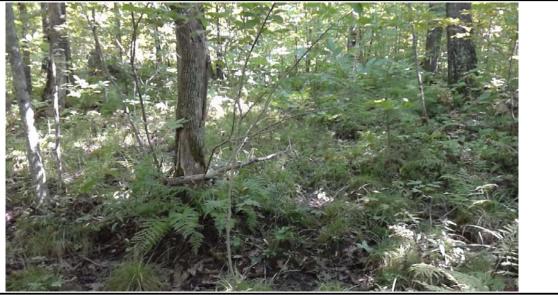
Site Photograph 1 Sampling Point: w-50n26w18-ag1

Latitude: 46.8171925424103	Cowardin Classification: PFO
Longitude: -93.6774710846075	Circular 39: 1
Direction: East	Eggers & Reed: Seasonally Flooded Basin
Remarks:

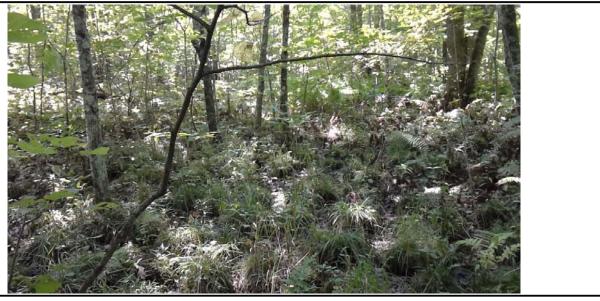
Site Photograph 2 Sampling Point: w-50n26w18-ag1

Latitude: 46.8171925005008	Cowardin Classification: PFO		
Longitude: -93.6774711684265	Circular 39: 1		
Direction: West	Eggers & Reed: Seasonally Flooded Basin		
Remarks:
