WETLAND DETERMINATION DATA FORM - North Central and Northeast Region

Project/Site: SPP	Cit	y/County: Aitkin		Sampling Date: 2016-08-19		
Applicant/Owner: Enbridge			State: Minnesota	Samplir	ng Point: w-50n26w18-b1	
Investigator(s): ZCW, MGH Section, Township, Range: S18, T50N, R26W						
Landform (hillslope, terrace, etc.): Depre	ssion		Local Relief (concave, co	onvex, none): CV	Slope (%): 0-2%	
Subregion (LRR or MLRA):		 Latitude: 46	i.8244501809 Lon	gitude: -93.68582507	Datum: NAD83	
Soil Map Unit Name: 1353B				NWI Cla	ssification: N/A	
Are climatic/hydrologic conditions on the	e site typica	Il for this time of year	? (if no, explain in Remar	ks):	No	
. , .	• • •	,		•		
Are Vegetation No_, Soil No_, or Hydrology No_ significantly disturbed? Are "Normal Circumstances" present? Yes Are Vegetation No_, Soil No_, or Hydrology No_ naturally problematic? (If needed, explain any answers in Remarks)						
SUMMARY OF FINDINGS - Attach site	map show	ring sampling point lo	cations, transects, impo	rtant features, etc.

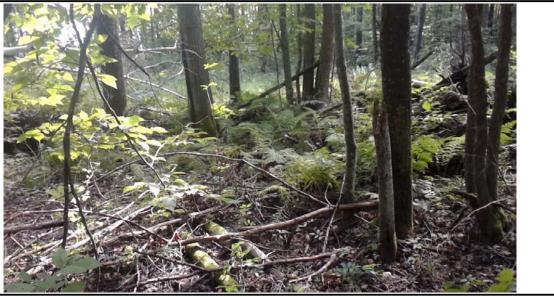
Site Photograph 1 Sampling Point: w-50n26w18-b1

and the second	
Latitude: 46.8243990932096	Cowardin Classification: PFO
Longitude: -93.6858768762031	Circular 39: 7
Direction: West	Eggers & Reed: Hardwood Swamp/Coniferous Swamp
Remarks:

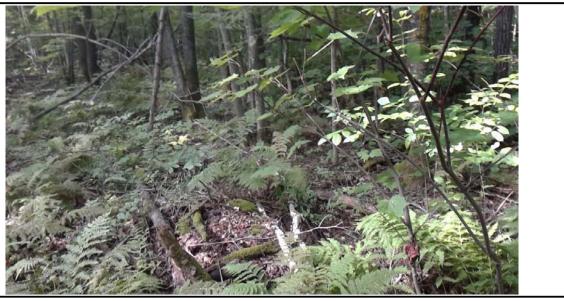
Site Photograph 2 Sampling Point: w-50n26w18-b1

Latitude:	46.8243989674811	Cowardin Classification: PFO		
Longitude:	-93.6858768762031	Circular 39: 7		
Direction: East		Eggers & Reed: Hardwood Swamp/Coniferous Swamp		
Remarks:
