## WETLAND DETERMINATION DATA FORM - North Central and Northeast Region

Project/Site: SPP	City/County: Aitkin		Sampling Date: 2016-08-19		
Applicant/Owner: Enbridge		State: Minnesota	Sampling Point: w-50n26w18-b2		
Investigator(s): ZCW, MGH	Section, Townshi	p, Range: S18, T50N, R26W			
Landform (hillslope, terrace, etc.): Depression	<u> </u>	Local Relief (concave, conv			
Subregion (LRR or MLRA):	 Latitude: 46		ude: -93.68568685 Datum: NAD83		
Soil Map Unit Name: 1353B			NWI Classification: N/A		
Are climatic/hydrologic conditions on the site ty	nical for this time of year	? (if no explain in Remarks)

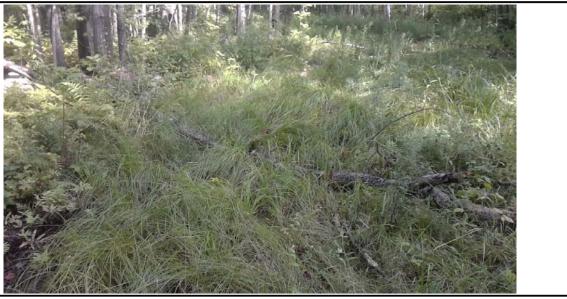
Site Photograph 1 Sampling Point: w-50n26w18-b2

Latitude: 46.8245744845335	Cowardin Classification: PEM	
Longitude: -93.68565467195	Circular 39: 2	
Direction: North	Eggers & Reed: Fresh (Wet) Meadow	
Remarks:

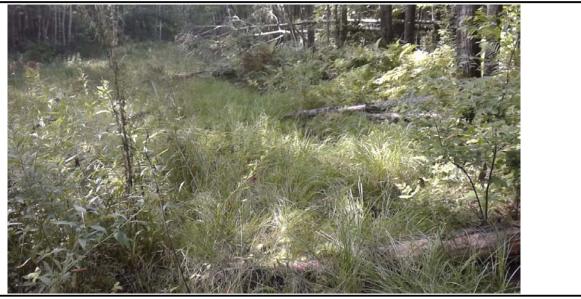
Site Photograph 2 Sampling Point: w-50n26w18-b2

Latitude: 46.8245746521715	Cowardin Classification: PEM
Longitude: -93.685654839588	Circular 39: 2
Direction: South	Eggers & Reed: Fresh (Wet) Meadow
Remarks:
