WETLA	ND DETERMIN/	ATION DATA F	FORM - North Central	and Northeast Re	gion	
Project/Site: SPP	e: SPP City/County: <u>Aitkin</u>			Sampling Date: 2016-08-19		
Applicant/Owner: Enbridge			State: Minnesota	Sar	mpling Point: <u>w-50n26</u> v	v18-d1
Investigator(s): ZCW, MGH	Se	ection, Townshi	ip, Range: <u>S18, T50N, R26</u>	5W		_
Landform (hillslope, terrace, etc.): Depres	ssion		Local Relief (concave, co	onvex, none): <u>CC</u>	Slope (%)	: 0-2%
Subregion (LRR or MLRA):		Latitude: 46	5.8225193256 Lon	ngitude: <u>-93.684702</u> 9	99 Datum: NAD8	3
Soil Map Unit Name: 204B				NW	/I Classification: N/A	
Are climatic/hydrologic conditions on the	e site typical for the	his time of year	? (if no, explain in Remar	rks):	No	
Are Vegetation <u>No</u> , Soil <u>No</u> , or Hyd	drology <u>No</u> sign	ificantly disturb	ped? Are "Normal Circun	nstances" present? <u>`</u>	Yes	
Are Vegetation <u>No</u> , Soil <u>No</u> , or Hydro	ology <u>No</u> natura	ally problemation	c? (If needed, explain an	וץ answers in Remar	'ks)

# Site Photograph 1

# Sampling Point: w-50n26w18-d1

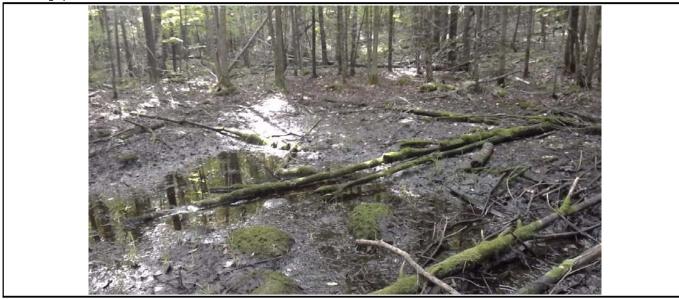
Cowardin Classification: PFO

Direction: South

Eggers & Reed: Seasonally Flooded Basin

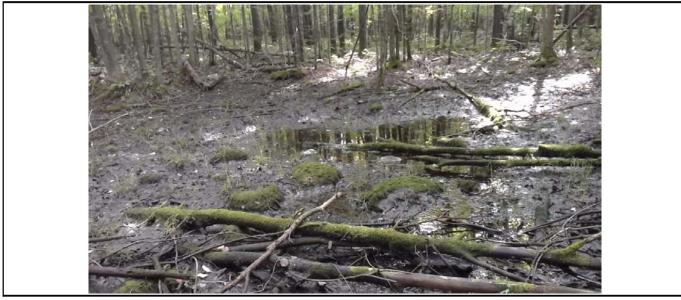
# Site Photograph 2

Sampling Point: w-50n26w18-d1

Cowardin Classification: PFO

Direction: East

Eggers & Reed: Seasonally Flooded Basin
