**WETLAND DETERMINATION DATA FORM - North Central and Northeast Region**

Project/Site: SPP City/County: Aitkin Sampling Date: 2016-08-19  
 Applicant/Owner: Enbridge State: Minnesota Sampling Point: w-50n26w18-f1  
 Investigator(s): ZCW, MGH Section, Township, Range: S18, T50N, R26W  
 Landform (hillslope, terrace, etc.): Depression Local Relief (concave, convex, none): CC Slope (%): 0-2%  
 Subregion (LRR or MLRA): \_\_\_\_\_ Latitude: 46.8208816275... Longitude: -93.68616269... Datum: NAD83  
 Soil Map Unit Name: 204B NWI Classification: N/A  
 Are climatic/hydrologic conditions on the site typical for this time of year? (if no, explain in Remarks): No  
 Are Vegetation No, Soil No, or Hydrology No significantly disturbed? Are "Normal Circumstances" present? Yes  
 Are Vegetation No, Soil No, or Hydrology No naturally problematic? (If needed, explain any answers in Remarks)

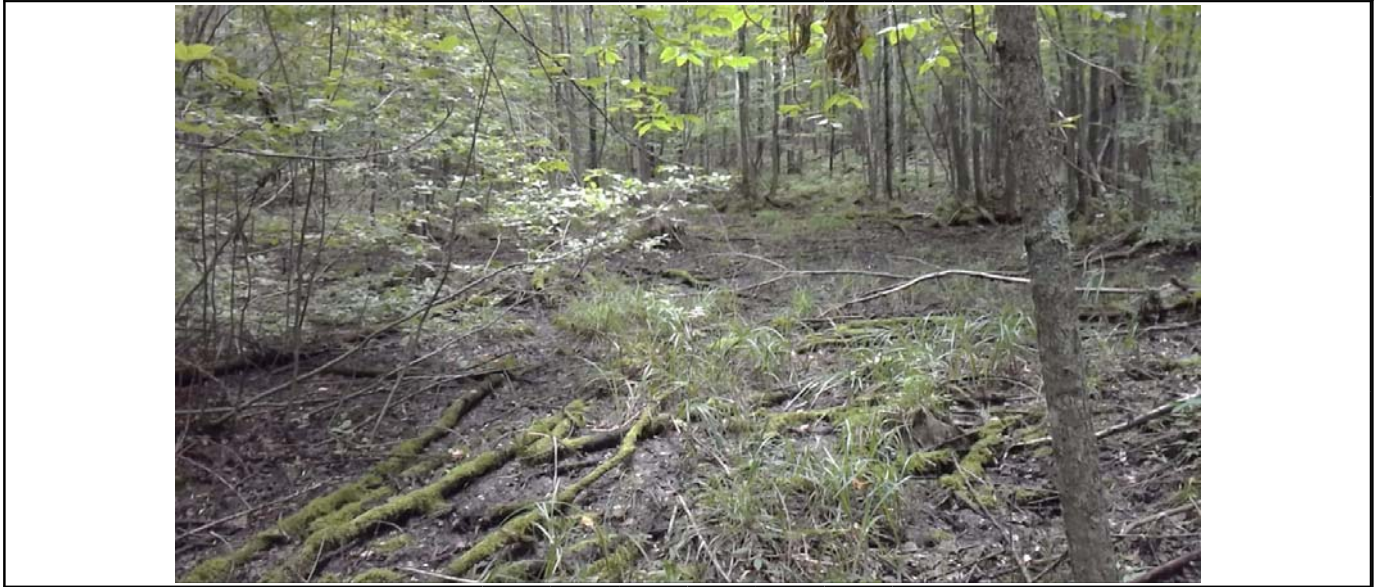
Site Photograph 1

Sampling Point: w-50n26w18-f1

Cowardin Classification: PFO

Direction: North

Eggers & Reed: Seasonally Flooded Basin

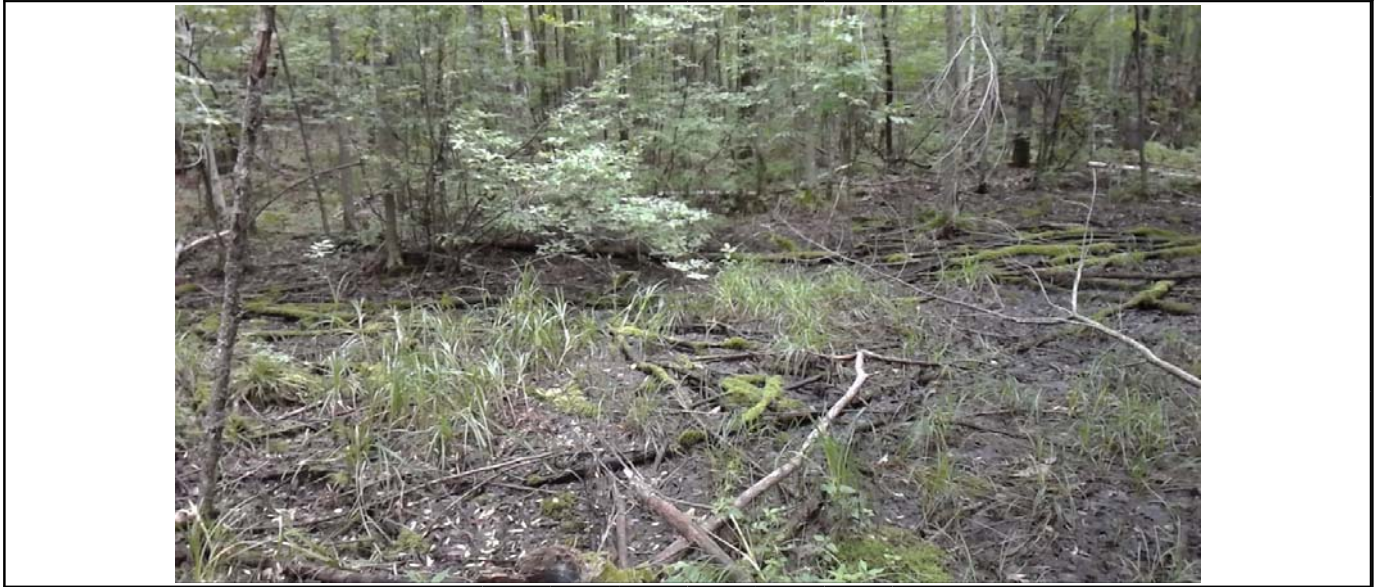
Site Photograph 2

Sampling Point: w-50n26w18-f1

Cowardin Classification: PFO

Direction: West

Eggers & Reed: Seasonally Flooded Basin
