WETLAND DETERMINATION DATA FORM - North Central and Northeast Region

Project/Site: SPP	City/County: Aitkin Sampling Date: 2016-08-19		g Date: 2016-08-19	
Applicant/Owner: Enbridge		State: Minnesota	Sampling	Point: w-50n26w18-h1
Investigator(s): ZCW, MGH	Section, Townshi	p, Range: S18, T50N, R26W	<u> </u>	
Landform (hillslope, terrace, etc.): Depression		Local Relief (concave, conv		Slope (%): 0-2%
Subregion (LRR or MLRA):	Latitude: 46	,	tude: -93.67893624	Datum: NAD83
Soil Map Unit Name: 928C	_			sification: N/A
Are climatic/hydrologic conditions on the site ty	pical for this time of vear	? (if no. explain in Remarks)		No

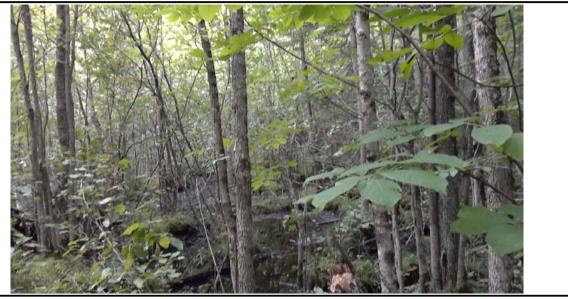
Site Photograph 1 Sampling Point: w-50n26w18-h1

Latitude: 46.8220503163029	Cowardin Classification: PSS		
Longitude: -93.6789226625987	Circular 39: 6		
rection: North	Eggers & Reed: Shrub-Carr/Alder Thicket		
emarks:			
and to
