WETLAND DETERMINATION DATA FORM - North Central and Northeast Region

Project/Site: SPP	c	ity/County: Aitkin		Samp	ling Date: 2016-08-19	
Applicant/Owner: Enbridge			State: Minnesota	Sampl	ing Point: w-50n26w18-i1	
Investigator(s): ZCW, MGH		Section, Township	p, Range: <u>\$18, T50N, R26</u>	5W		
Landform (hillslope, terrace, etc.): Depre	ession		Local Relief (concave, co	nvex, none): CC	Slope (%): 0-2%	
Subregion (LRR or MLRA):		 Latitude: 46	5.8227470200 Lon	gitude: -93.67855964	. Datum: NAD83	
Soil Map Unit Name: 928C				NWI C	assification: N/A	
Are climatic/hydrologic conditions on th	e site typic	cal for this time of year	? (if no. explain in Remarl		No	
Are Vegetation No , Soil No , or Hy Are Vegetation No , Soil No , or Hydr						
SUMMARY OF FINDINGS - Attach site	e map show	wing sampling point lo	cations, transects, impo	rtant features, etc.		
Hydrophytic Vegetation Present?	·	Yes	Is the Sampled Area			
Hydric Soil Present?		Yes	within a Wetland?		Yes	
Wetland Hydrology Present?		Yes	If yes, optional Wetland	Site ID:	w-50n26w18-i

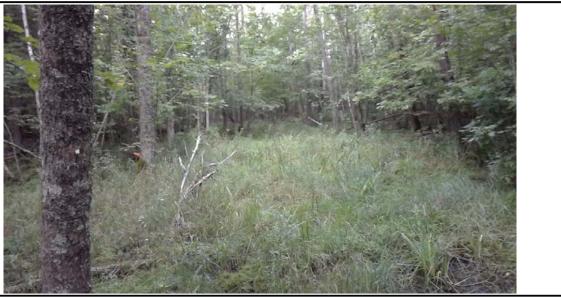
Site Photograph 1 Sampling Point: w-50n26w18-i1

Latitude: 46.8227334414114	Cowardin Classification: PFO
Longitude: -93.678545393137	Circular 39: 1
Direction: Northwest	Eggers & Reed: Seasonally Flooded Basin
Remarks:

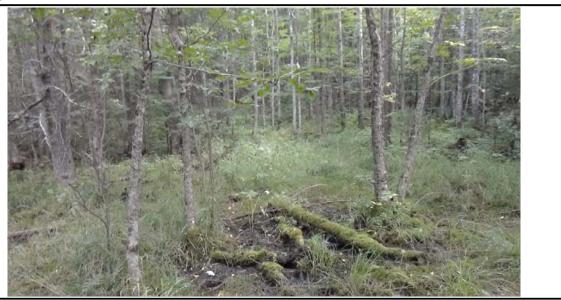
Site Photograph 2 Sampling Point: w-50n26w18-i1

Latitude: 46.8227339862351	Couradia Classification, DEO
	Cowardin Classification: PFO
Longitude: -93.6785444711276	Circular 39: 1
ection: Northeast	Eggers & Reed: Seasonally Flooded Basin
marks:
