## WETLAND DETERMINATION DATA FORM - North Central and Northeast Region

Project/Site: SPP	C	ity/County: Aitkin		Sampling Date: 2016-08-22			
Applicant/Owner: Enbridge			State: Minnesota	Sampli	ng Point: <u>w-50n26w18-j1</u>		
Investigator(s): ZCW, MGH		Section, Townshi	p, Range: S18, T50N, R26	W			
Landform (hillslope, terrace, etc.):	epression		Local Relief (concave, con	nvex, none): CC	Slope (%): 0-2%		
Subregion (LRR or MLRA):		 Latitude: 46	5.8254535785 Long	 gitude: -93.67770284	Datum: NAD83		
Soil Map Unit Name: 204B				NWI Cla	assification: N/A		
Are climatic/hydrologic conditions of	n the site typic	al for this time of year	? (if no. explain in Remark		No		
Are Vegetation No , Soil No , or		<del></del>			-		
SUMMARY OF FINDINGS - Attac	h site map sho	ving sampling point lo	cations, transects, impor	tant features, etc.			
Hydrophytic Vegetation Present?		Yes	Is the Sampled Area				
Hydric Soil Present?		Yes	within a Wetland?		Yes		
Wetland Hydrology Present?		Yes	If yes, optional Wetland	Site ID:	w-50n26w18-j

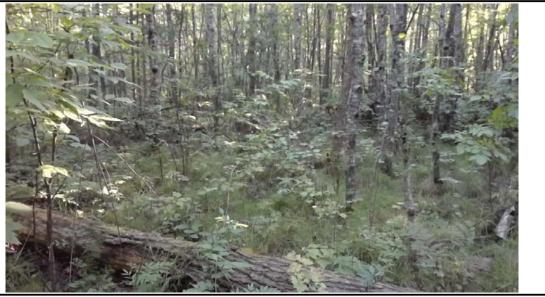
Site Photograph 1 Sampling Point: w-50n26w18-j1

tude: -93.6777066999056 Circular 39: 1	Latitude: 46.8254726892773	Cowardin Classification: PFO	
	Longitude: -93.6777066999056	Circular 39: 1	
Northeast Eggers & Reed: Seasonally	ection: Northeast	Eggers & Reed: Seasonally Flooded Basin
